**ADDENDUM # 2**  
**BID # FY 2015-2016-CRA003**  
**FDEM GRANT RESIDENTIAL WIND MITIGATION RETROFIT IMPROVEMENTS**

# RESIDENTIAL PROPERTY WIND-STORM PROTECTION ASSESSMENT

**1124 NE 6<sup>th</sup> Street  
Hallandale Beach, FL 33009**

<b>In Regards To</b>	1124 NE 6 <sup>th</sup> Street, Hallandale Beach, FL 33009		
<b>Prepared For</b>	City of Hallandale Beach	<b>Assessment Date</b>	February 03, 2016
<b>Requested By</b>	Community Redevelopment Agency	<b>Year Built</b>	1956
<b>Soil &amp; Weather</b>	Dry Soil & Sunny • 83 °F	<b>Property ID</b>	5142-22-37-0600

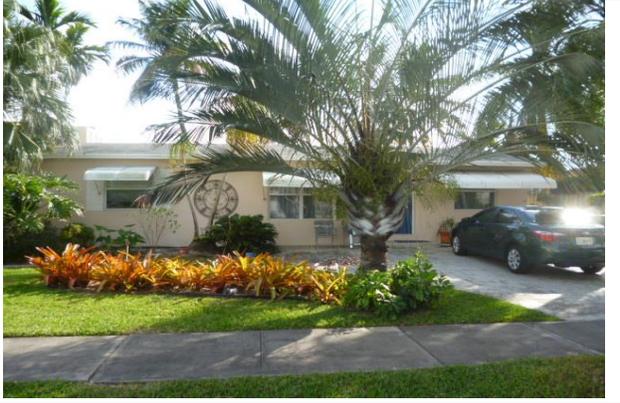
<p><i>As Photographed on</i></p> <p><b>Wednesday, February 03<sup>rd</sup>, 2016</b></p> <p>(1)</p> <p><i>The subject property building face North</i></p>

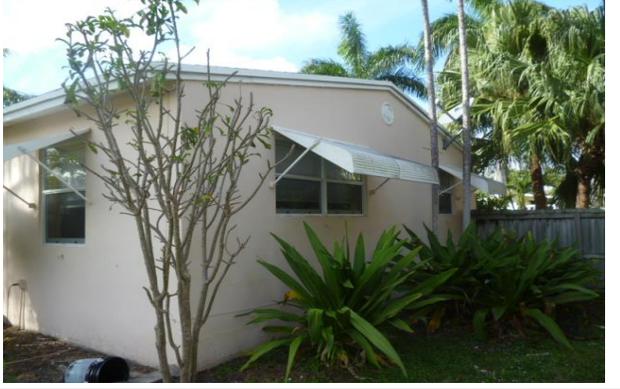
<p>(2)</p> <p><i>The subject property East elevation view</i></p>

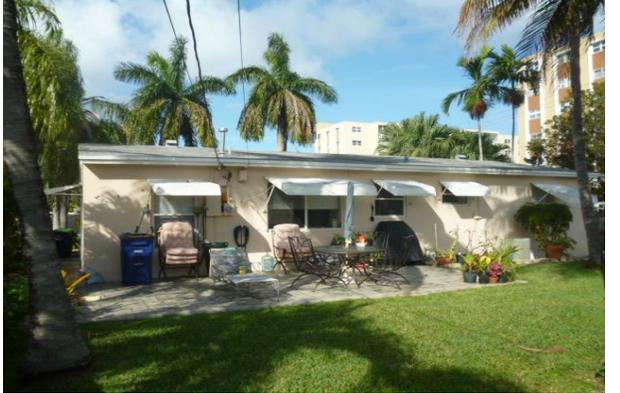
<p>(3)</p> <p><i>The subject property South elevation view</i></p>

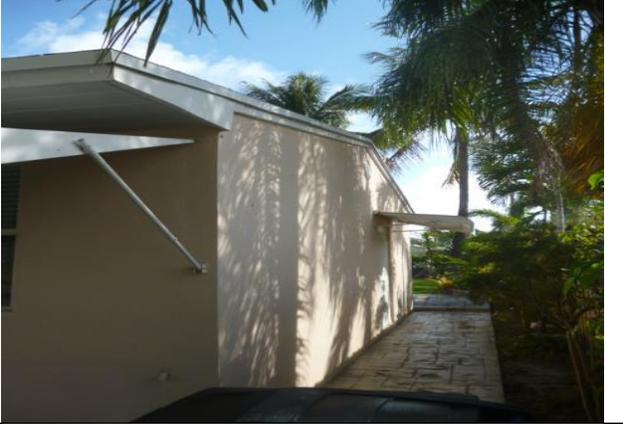
<p>(4)</p> <p><i>The subject property West elevation view</i></p>

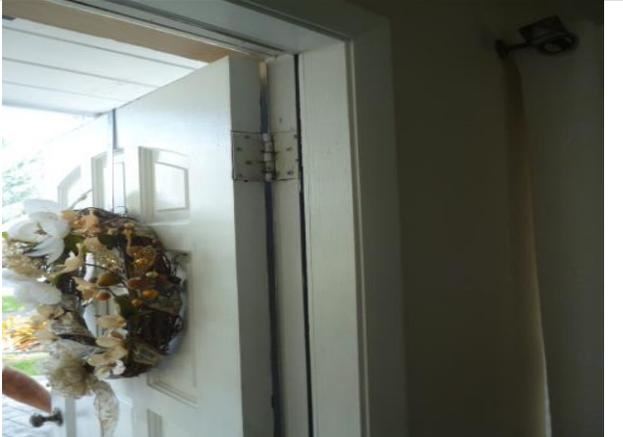
<p>(6)</p> <p><i>The subject property main entry door side view</i></p>

The window glazed openings have no proper storm protection. The window glazed openings and exterior doors/frames are recommended to be covered with storm protected built-in storm shutter panels. The two exterior door panels, frames, and sashes are recommended to be replaced with proper exterior door panels.

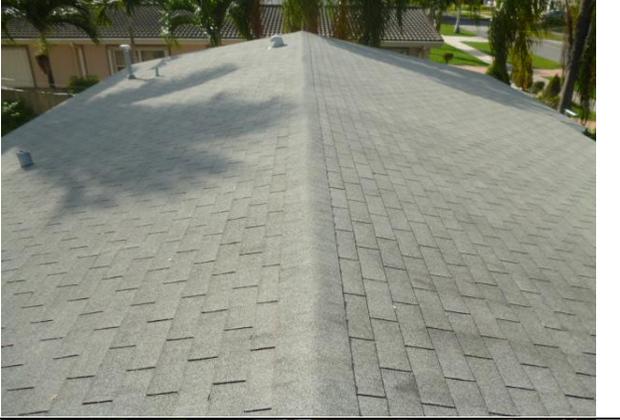
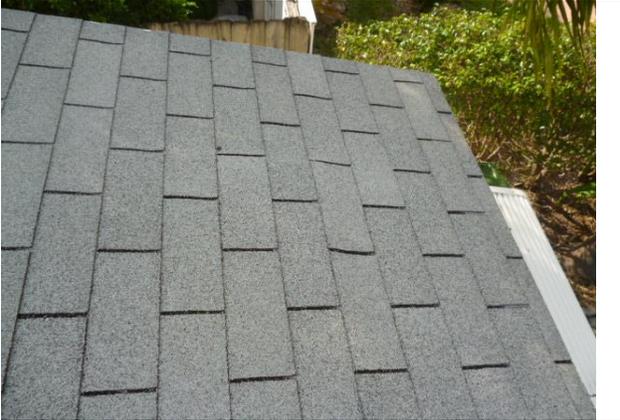
<p>(7)</p> <p><i>The subject property partial view of the main asphalt shingle roof</i></p>

<p>(8)</p> <p><i>The subject property partial view of the main asphalt shingle roof</i></p>

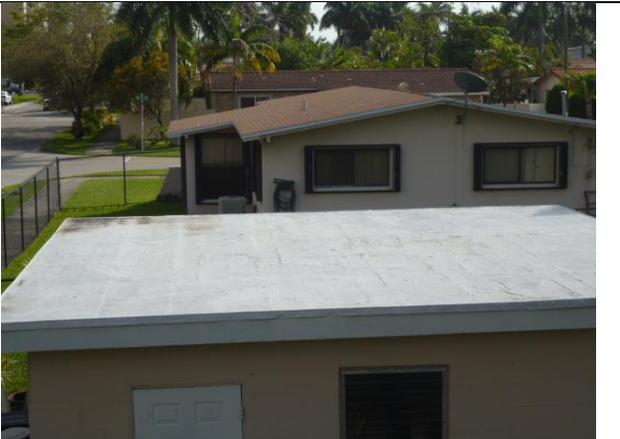
The main asphalt shingle roof system appears to be in good condition No significant damage noted on the main building roof. The detached garage building flat BUR roof rolled composition material has significant water penetration damages through the interior ceiling wooden elements at the SE corner of the property. It is highly recommended that the flat roof cover and water damaged elements to be serviced, replaced, and maintained soon. The protrusions on the main roof surface need to be always properly sealed and maintained. The roof wooden deck panels, fascia boards, and soffit/eaves have some deterioration. Those fascia boards and soffit areas need to be partially repaired and maintained along with proper vent screens and they all should be maintained as needed in the future.

<p>(9)</p> <p><i>The subject property overall view of the detached garage building flat roof</i></p>

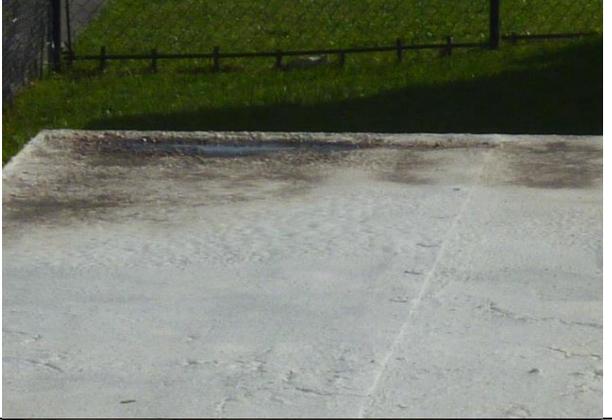
The detached building flat BUR roof rolled composition material has significantly deteriorated along with excessive granular loss on the surface. The flat roof is highly recommended to be replaced along with water damaged interior wooden ceiling elements partial replacement.

<p>(10)</p> <p><i>The subject property deteriorated detached garage building flat roof has excessive granular loss and it is recommended to be replaced</i></p>

All those damaged and unsafe roof system elements are highly recommended to be replaced with proper installation immediately. For the evaluation process, it is highly recommended that the entire installation works to be performed by under the supervision of a State of Florida Certified General and/or Roofing Contractors.

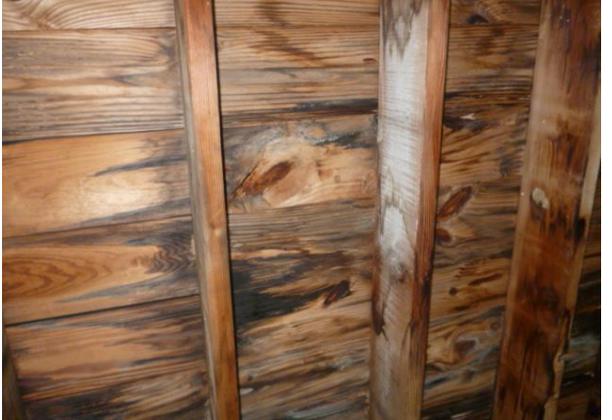
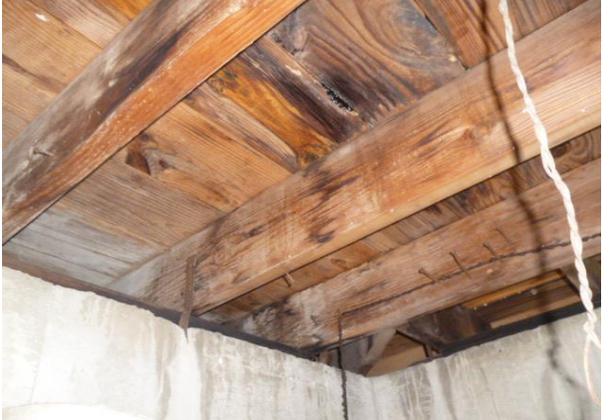
<p>(11)</p> <p><i>The subject property deteriorated detached garage building wooden ceiling elements have water penetration damages</i></p>

<p>(12)</p> <p><i>The subject property deteriorated detached garage building wooden ceiling elements have water penetration damages</i></p>

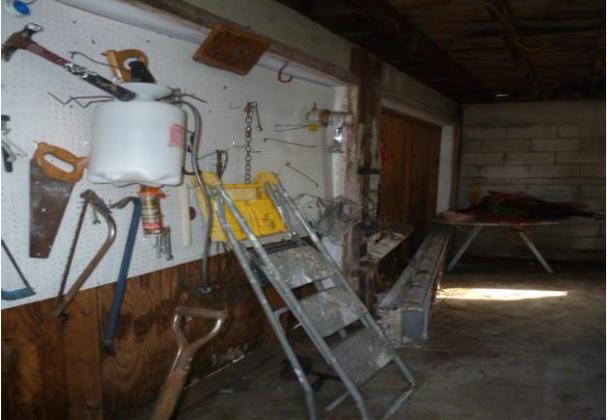
<p>(13)</p> <p><i>The subject property detached garage building structure has no proper built-in garage doors</i></p>

The detached garage building has no garage doors and recommended to be installed soon to protect the structure. However, there are major floor cracks, significant settlement, and improper slope noted toward East elevation that must be further evaluated prior to any garage door installation and roof replacement/maintenance work in this detached building. The water damaged garage door space frames also need to be replaced.

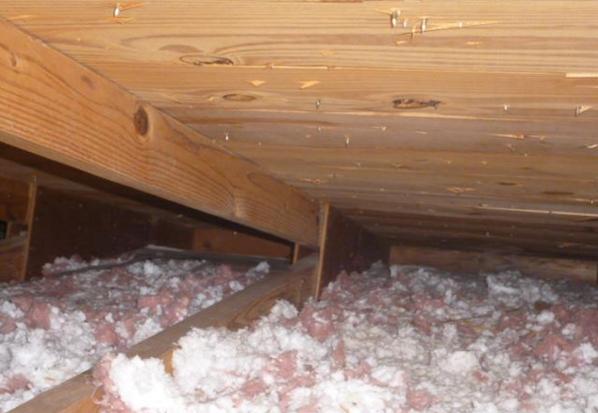
<p>(16)</p> <p><i>The subject property roof deck/structure attachments in the attic</i></p>

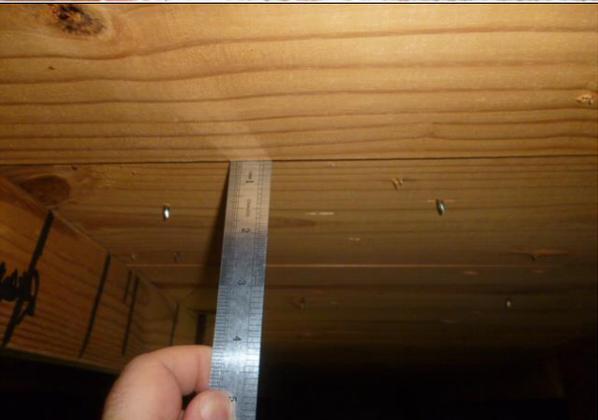
<p>(17)</p> <p><i>The subject property roof deck thickness view in the attic</i></p>

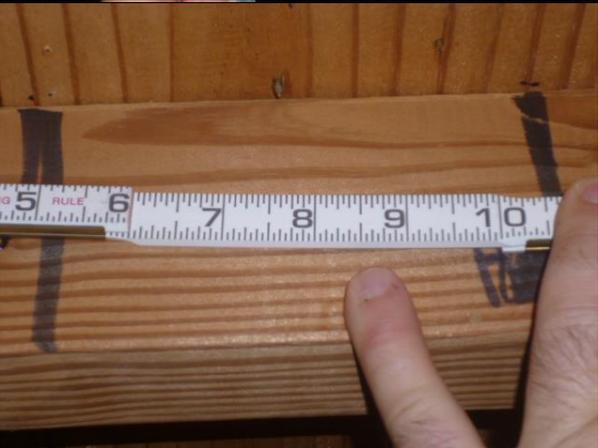
<p>(18)</p> <p><i>The subject property nail spacing view in the attic</i></p>

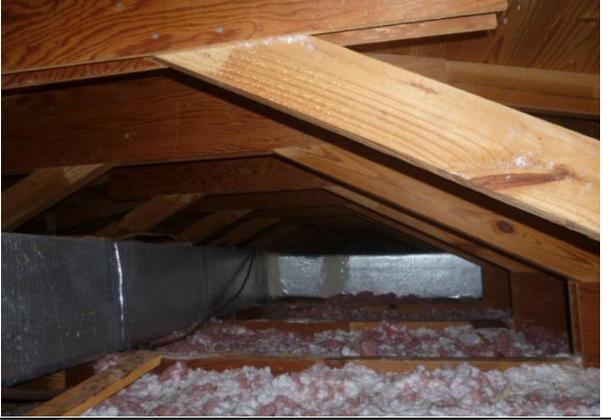
<p>(19)</p> <p><i>The subject property partial view of the attic</i></p>

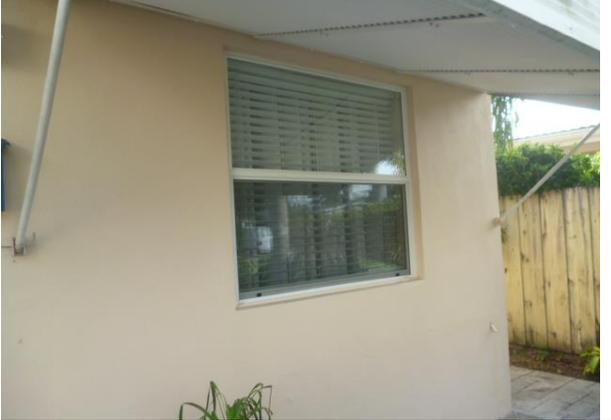
<p>(20)</p> <p><i>The subject property window glazed openings have no proper built-in storm protection</i></p>

The window glazed openings need built-in storm shutters to be fully protected, exterior door panels, two-car garage door and frames also are in need of full replacement and installation.
