HBCRA BID # FY 2015-2016-CRA003
 FDEM GRANT RESIDENTIAL WIND MITIGATION
 RETROFIT IMPROVEMENTS

RCMP PIS

7	HOMEOWNER NAME	Sealey, Brian J & Kathryn
8	PROPERTY ADDRESS	311 SW 10 Terrace
9	CITY AND ZIP	Hallandale Beach FL 33009
10	COUNTY	BROWARD
11	PROPERTY TAX ID NUMBER:	5142-28-29-0320

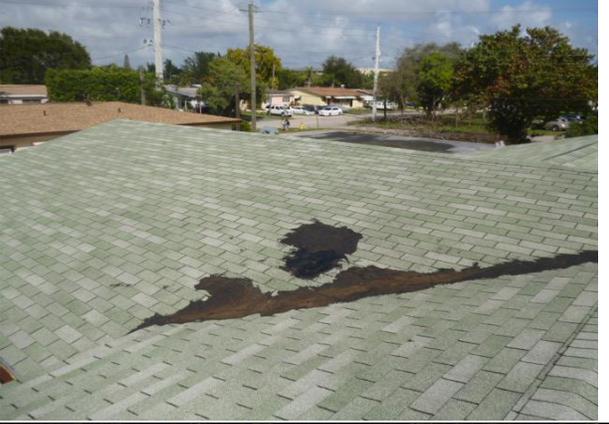
<p>(7)</p> <p><i>The subject property partial view of the main asphalt shingle roof</i></p>

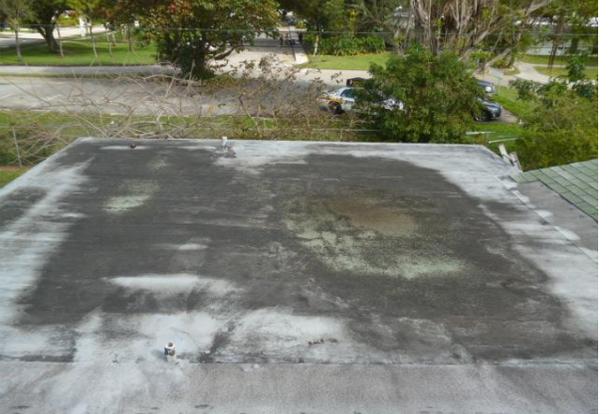
The subject property NE corner flat rolled composition roof material is significantly damaged, deteriorated with excessive granular loss and the flat roof must be fully replaced to prevent any further leak through the interior ceilings. The detached building flat roof system also deteriorated and it is recommended the flat roofs to be fully replaced since the water penetration damages are consistent.

<p>(8)</p> <p><i>The subject property severely deteriorated flat roof rolled composition materials need to be replaced soon</i></p>

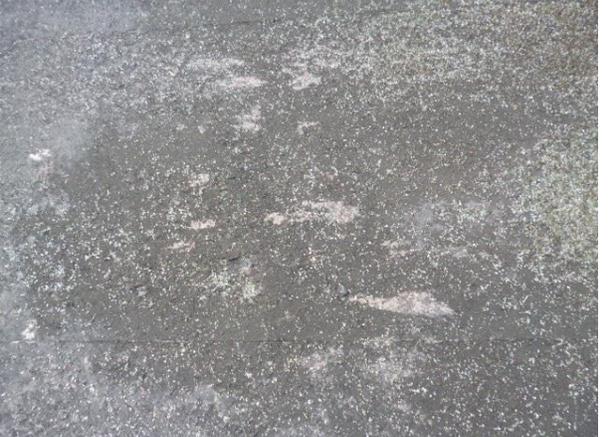
<p>(9)</p> <p><i>The subject property severely deteriorated flat roof rolled composition materials have excessive granular loss</i></p>

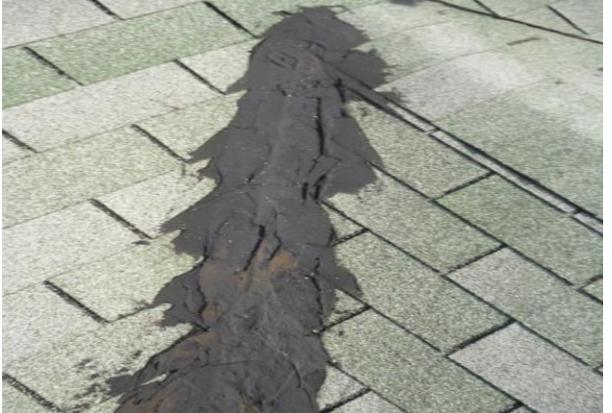
The main asphalt shingle roof system appears to be in fair condition with some exceptions along the valley joints and around the protrusions. Damaged shingles and substandard workmanship noted on the poorly repaired roof valley joints. The protrusions also poorly repaired around. Those damaged roof shingles need immediate attention to be replaced and repaired soon.

<p>(10)</p> <p><i>The subject property poor repairs on the main shingle roof valleys/joint sections need to be repaired properly</i></p>

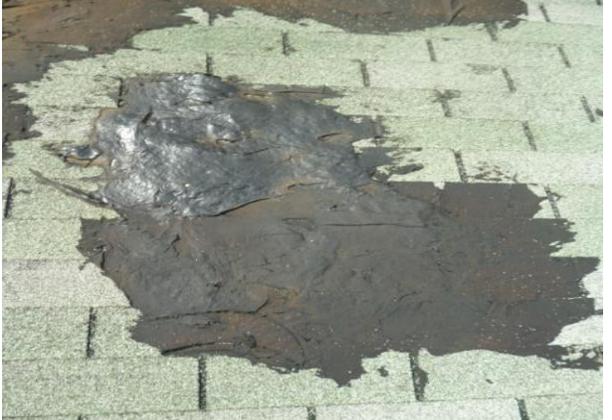
<p>(11)</p> <p><i>The subject property poor repairs on the main shingle roof surface needs to be repaired properly</i></p>

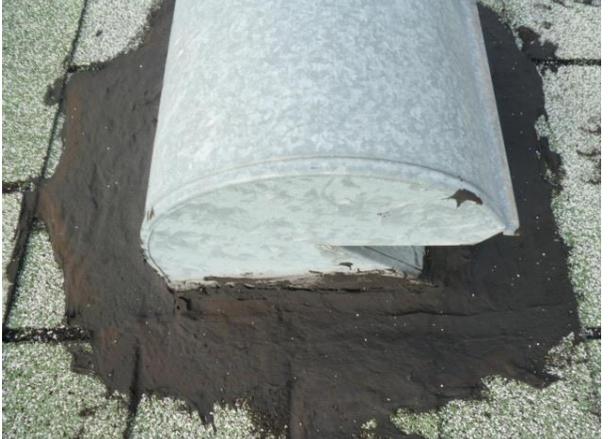
<p>(12)</p> <p><i>The subject property poor sealing/repairs around the protrusions on the main shingle roof surface must be maintained/repaired properly</i></p>

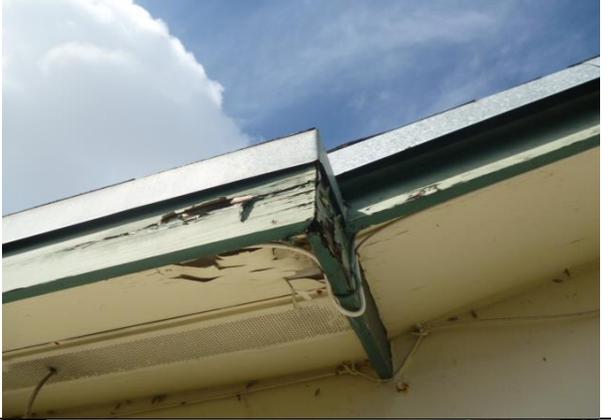
The roof wooden deck panels, fascia boards, and soffit/eaves have significant deterioration and some rot along with water intrusion and penetration damages. The interior ceilings have water penetration damages along with rot elements in the subject property. Those fascia boards and soffit need to be partially replaced along with proper vent screens and they all should be maintained as needed in the future.

<p>(13)</p> <p><i>The subject property fascia boards/soffit/eaves have deteriorations and need to be repaired/maintained soon</i></p>

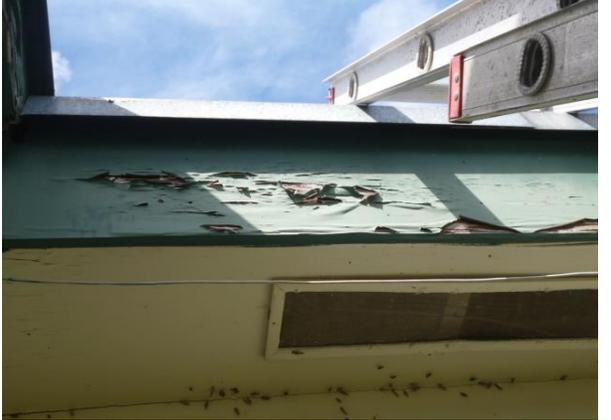
<p>(14)</p> <p><i>The subject property fascia boards/soffit/eaves have deteriorations and need to be repaired/maintained soon</i></p>

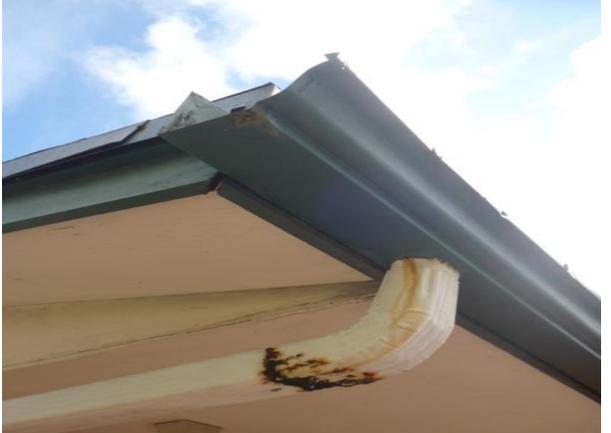
<p>(15)</p> <p><i>The subject property roof drainage elements; gutters & downspouts need to be maintained/replaced soon to prevent further water intrusion</i></p>

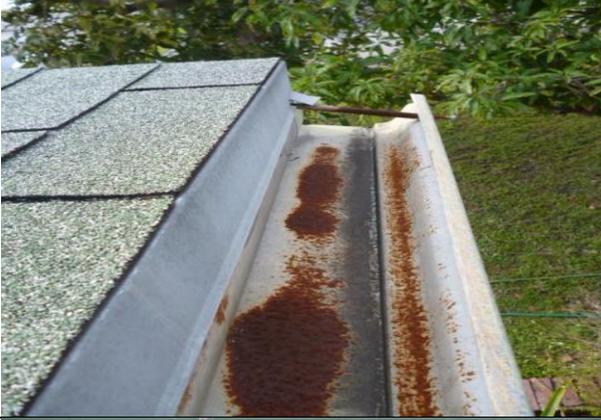
<p>(19)</p> <p><i>The subject property roof drainage elements; improper/rusty gutters need to be maintained/replaced soon to prevent further water intrusion</i></p>

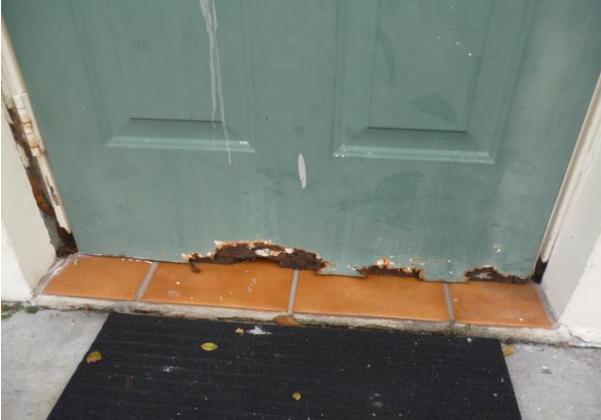
The window glazed openings have no storm protection. The window glazed openings and severely damaged exterior doors/frames are recommended to be replaced with storm protected built-in storm shutters. The four exterior door panels, frames, and sashes are deteriorated along with seals are in poor condition and recommended to be replaced with proper exterior door panels as well.

<p>(20)</p> <p><i>The subject property severely damaged/rusty exterior doors and frames need to be replaced</i></p>

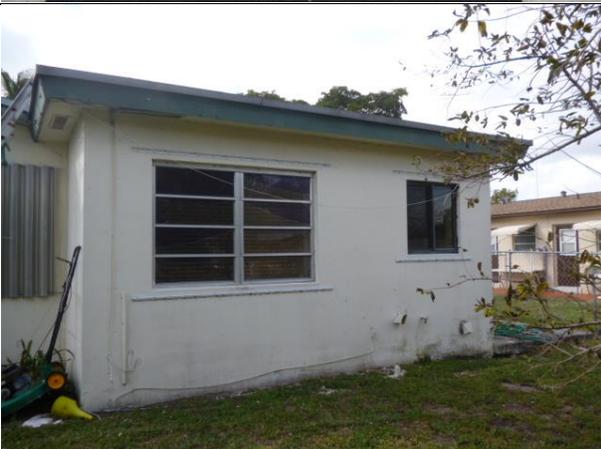
<p>(21)</p> <p><i>The subject property window glazed openings have no built-in storm protection</i></p>

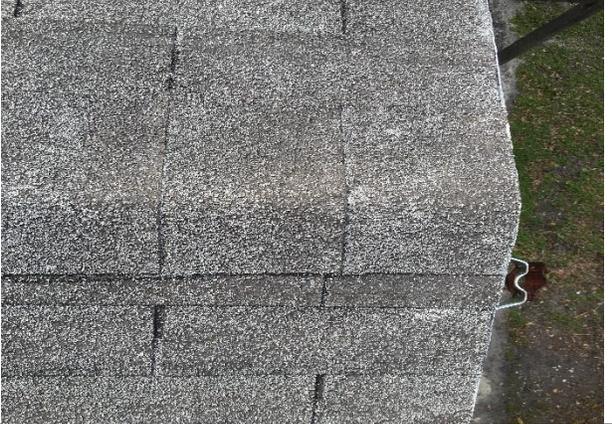
<p>(10)</p> <p><i>The subject property main roof shingles have excessive granular loss</i></p>

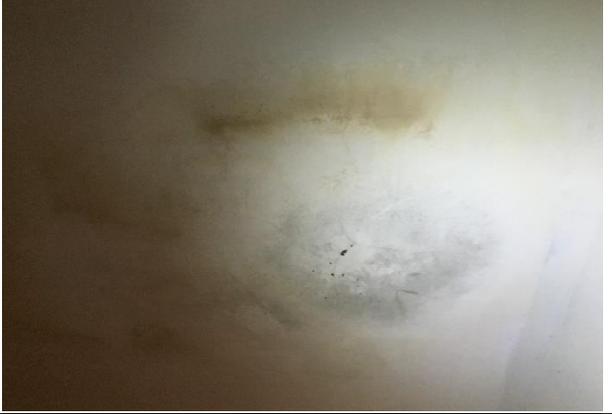
<p>(11)</p> <p><i>The subject property interior ceilings have significant leak evidence and they all needs to be repaired/replaced soon</i></p>

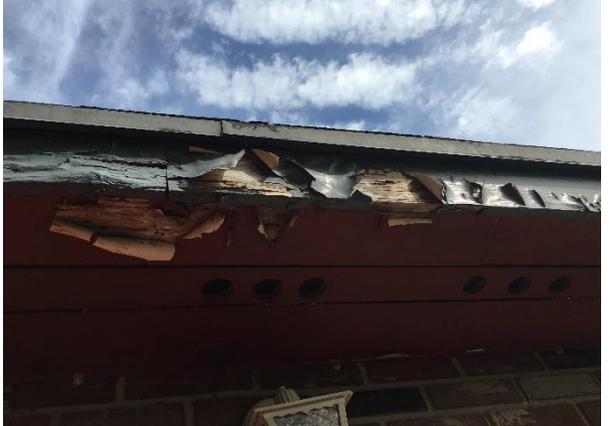
<p>(12)</p> <p><i>The subject property severely deteriorated fascia boards and soffit/eaves need to be replaced</i></p>

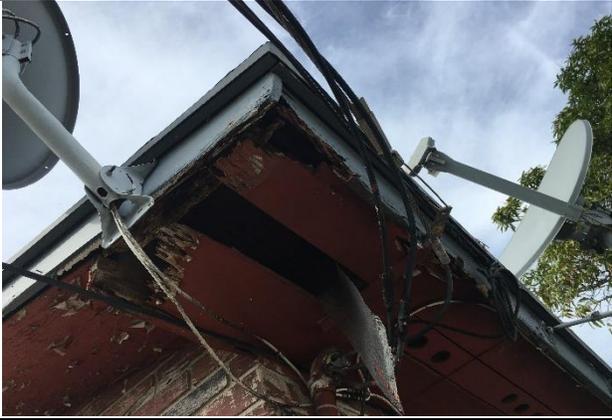
<p>(17)</p> <p><i>The subject property severely deteriorated fascia boards and soffit/eaves need to be replaced</i></p>

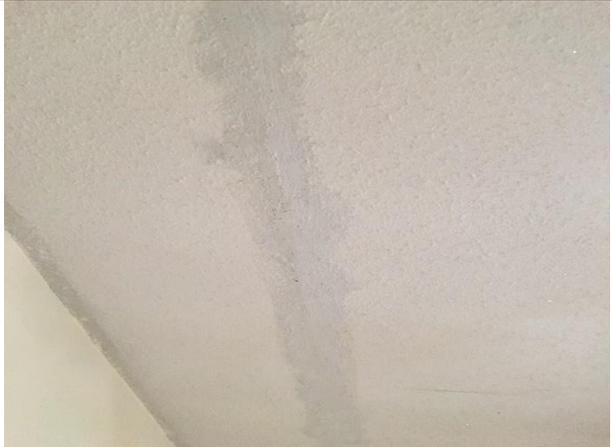
<p>(18)</p> <p><i>The subject property damaged and poorly repaired interior ceilings</i></p>

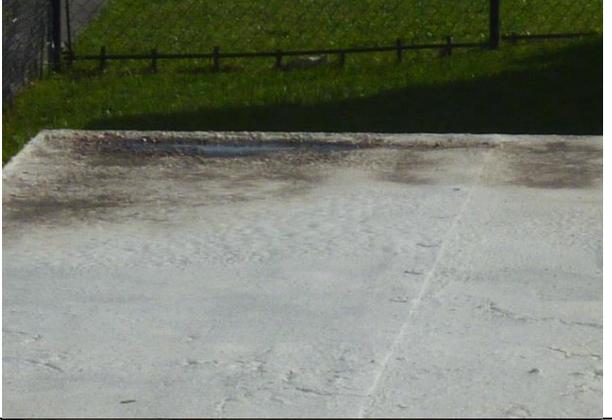
<p>(10)</p> <p><i>The subject property deteriorated detached garage building flat roof has excessive granular loss and it is recommended to be replaced</i></p>

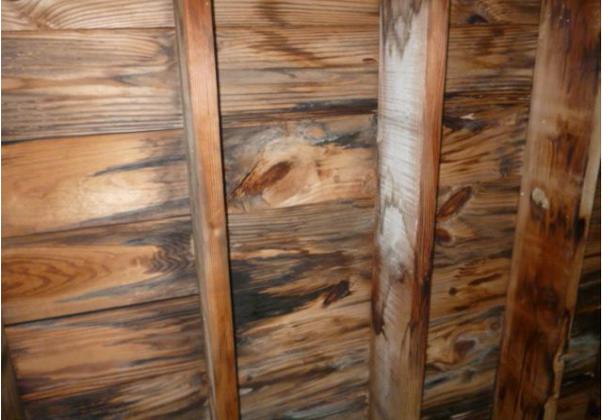
<p>(11)</p> <p><i>The subject property deteriorated detached garage building wooden ceiling elements have water penetration damages</i></p>

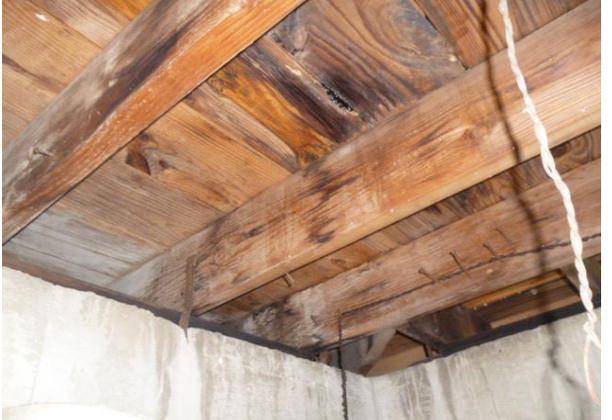
<p>(12)</p> <p><i>The subject property deteriorated detached garage building wooden ceiling elements have water penetration damages</i></p>

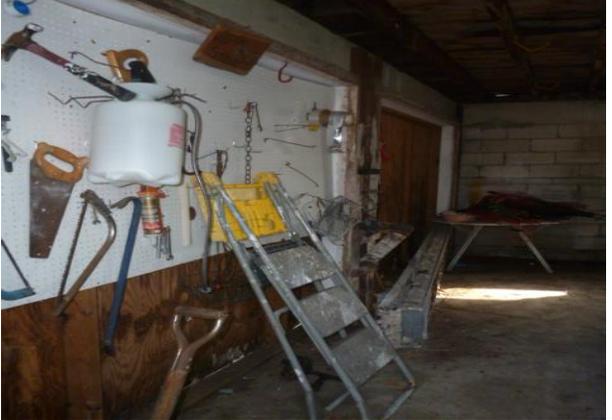
<p>(13)</p> <p><i>The subject property detached garage building structure has no proper built-in garage doors</i></p>

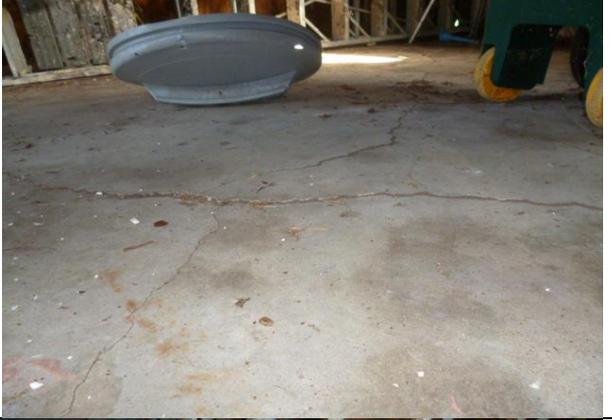
<p>(14)</p> <p><i>The subject property detached garage building concrete floor has severe cracks and improper slope toward east elevation</i></p>

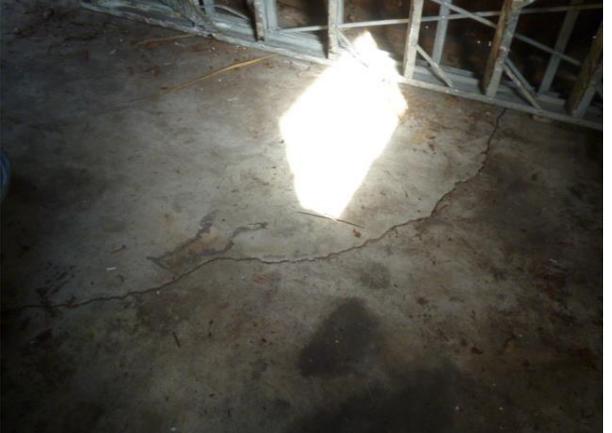
<p>(15)</p> <p><i>The subject property detached garage building concrete floor has severe cracks and improper slope toward east elevation</i></p>

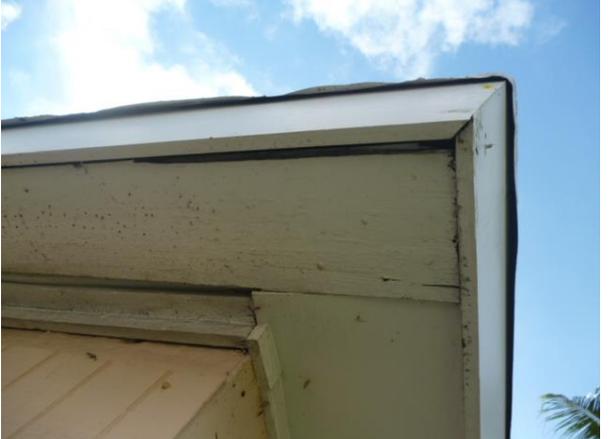
<p>(21)</p> <p><i>The subject property soffit/eaves need to be maintained</i></p>

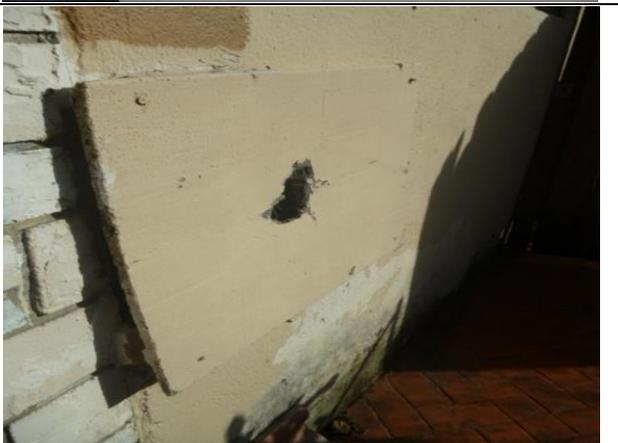
<p>(21)</p> <p><i>The subject property wall openings by the garage area on West elevation exterior walls must be enclosed soon</i></p>

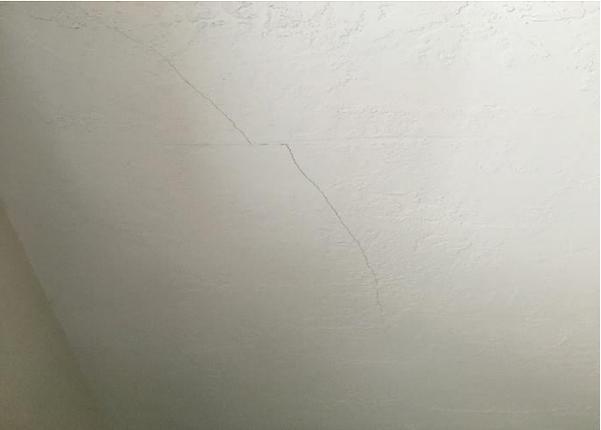
<p>(11)</p> <p><i>The subject property interior ceilings have typical cracks and recommended to be repaired</i></p>

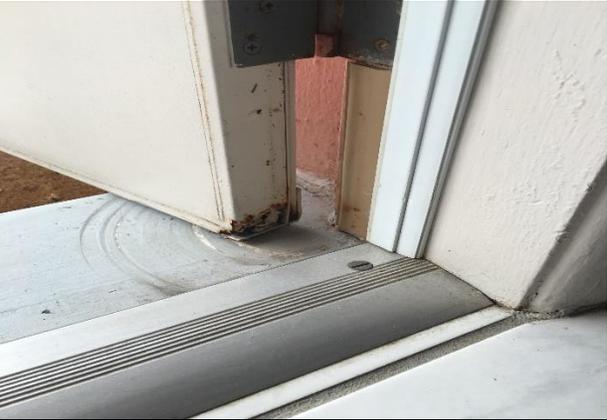
<p>(17)</p> <p><i>The subject property exterior door panels have water damages at lower portions</i></p>

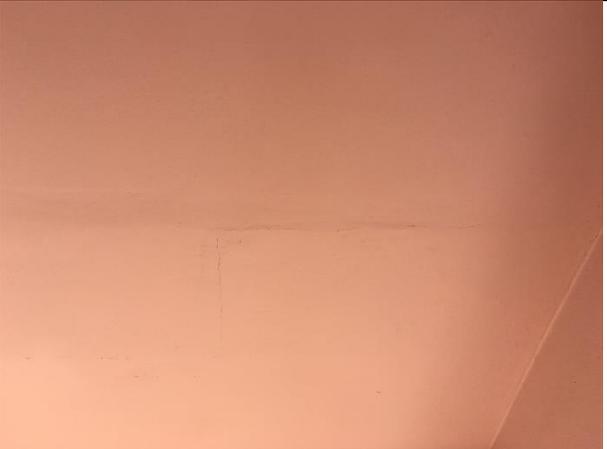
<p>(18)</p> <p><i>The subject property carport ceiling has previous repairs</i></p>

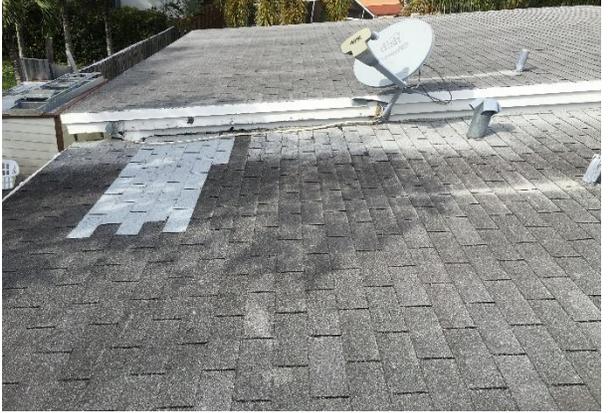
<p>(8)</p> <p><i>The subject property damaged and poorly repaired asphalt shingle roof cover materials recommended to be replaced</i></p>

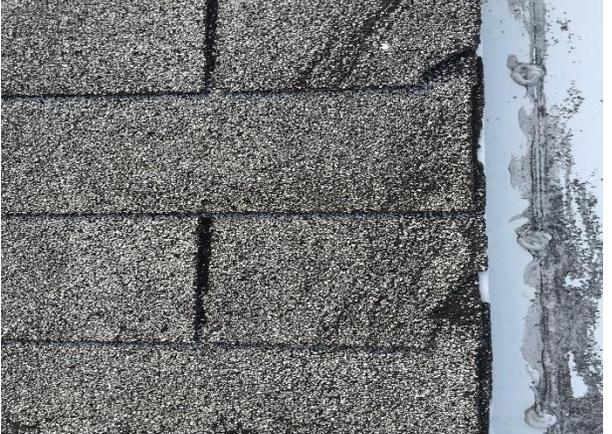
<p>(9)</p> <p><i>The subject property main roof shingles have excessive granular loss</i></p>

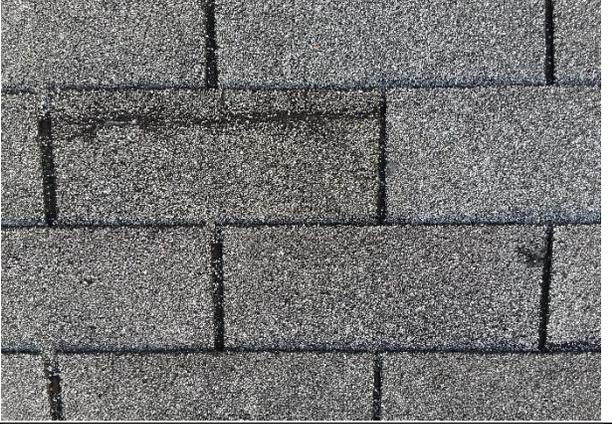
<p>(10)</p> <p><i>The subject property main roof shingles have excessive granular loss</i></p>

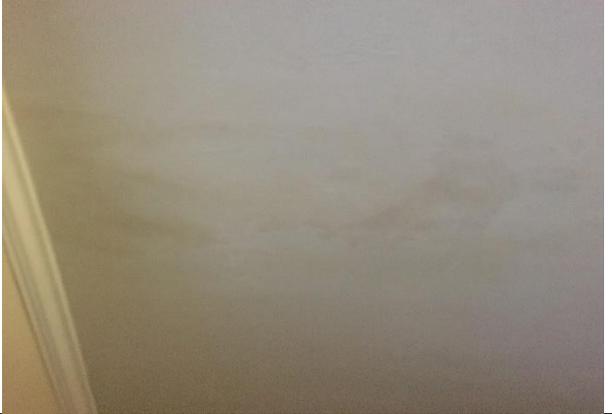
<p>(11)</p> <p><i>The subject property interior ceilings have leak evidence and they all needs to be repaired/replaced soon</i></p>

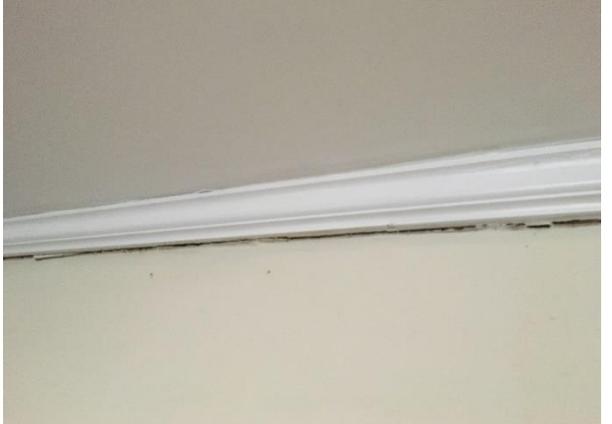
<p>(12)</p> <p><i>The subject property interior ceilings have water damage evidence and they all needs to be repaired/replaced soon</i></p>

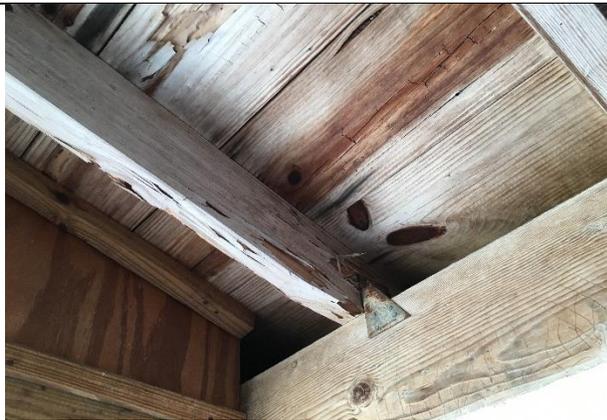
<p>(17)</p> <p><i>The subject property carport deteriorated wooden ceiling elements</i></p>

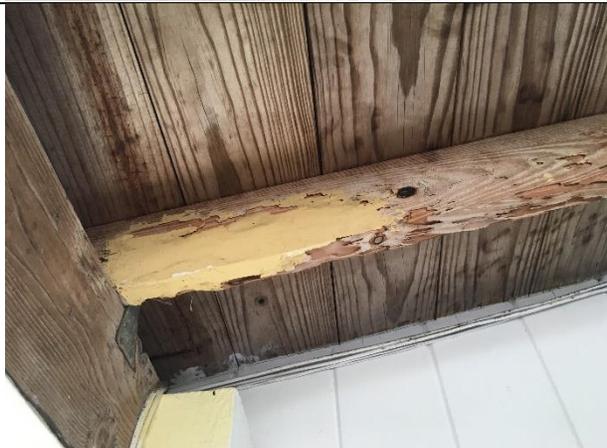
<p>(18)</p> <p><i>The subject property carport deteriorated wooden ceiling elements</i></p>

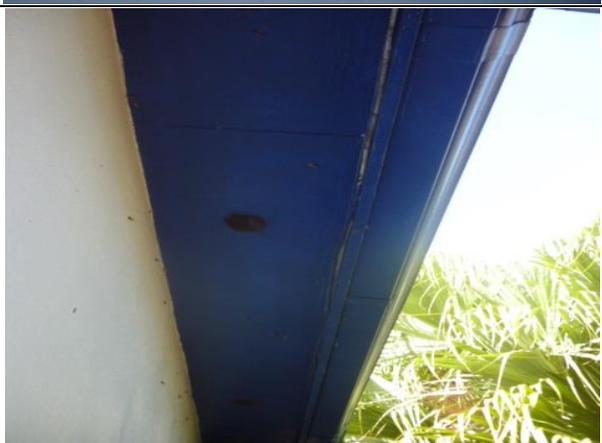
<p>(6)</p> <p><i>The subject property deteriorated soffit/eaves/fascia boards need to be maintained</i></p>

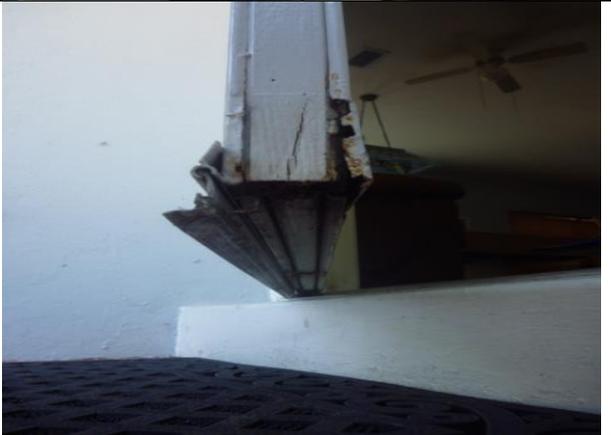
<p>(8)</p> <p><i>The subject property severely deteriorated/rot exterior doors</i></p>

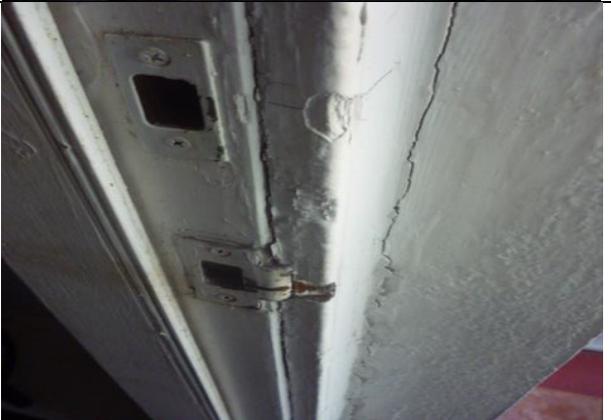
<p>(9)</p> <p><i>The subject property deteriorated exterior door frames need to be replaced</i></p>

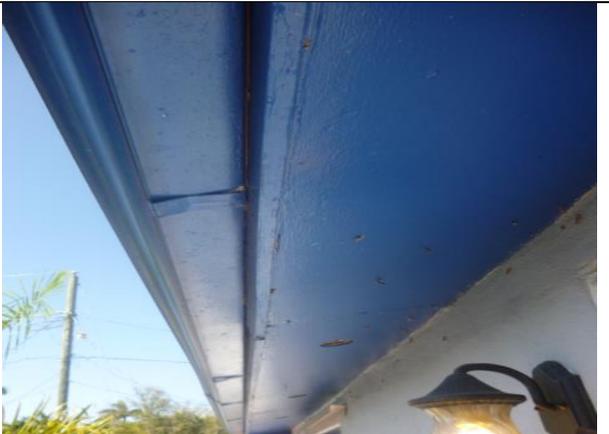
<p>(12)</p> <p><i>The subject property deteriorated soffit/eaves need to be maintained</i></p>

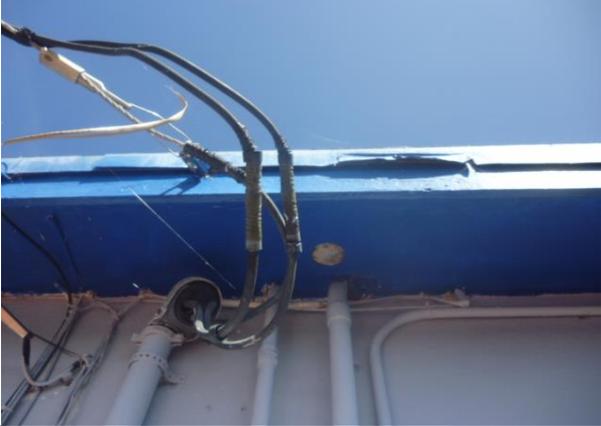
<p>(13)</p> <p><i>The subject property deteriorated fascia boards need to be maintained</i></p>

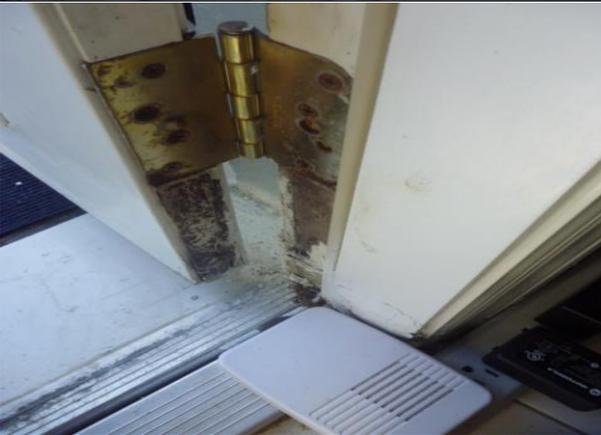
<p>(14)</p> <p><i>The subject property severely deteriorated/rot exterior doors</i></p>

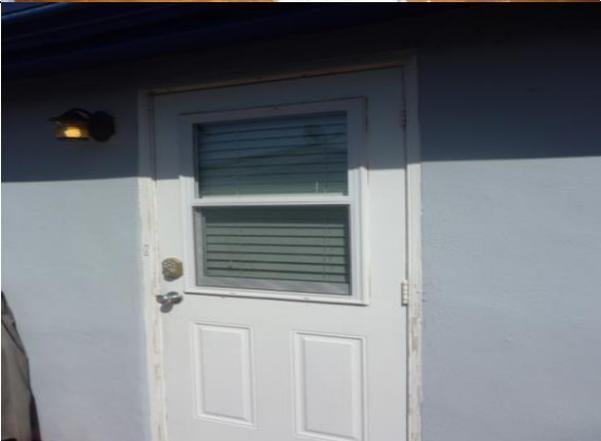
<p>(21)</p> <p><i>The subject property exterior doors have no storm protection</i></p>

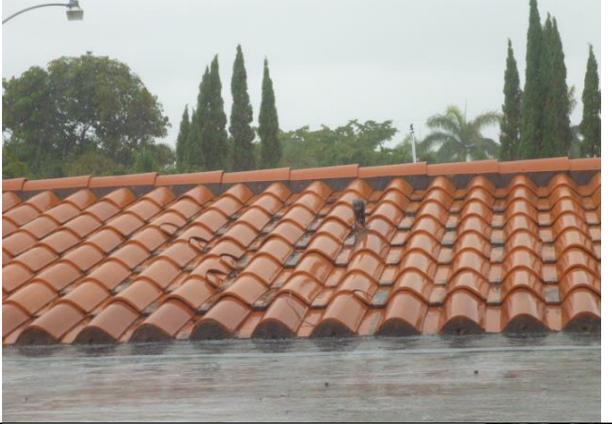
<p>(7)</p> <p><i>The subject property broken tiles must be replaced on the main roof</i></p>

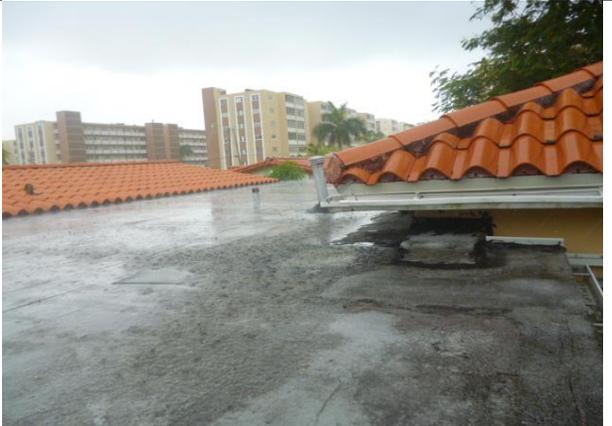
<p>(8)</p> <p><i>The subject property severely deteriorated flat roof surface cover is recommended to be replaced</i></p>

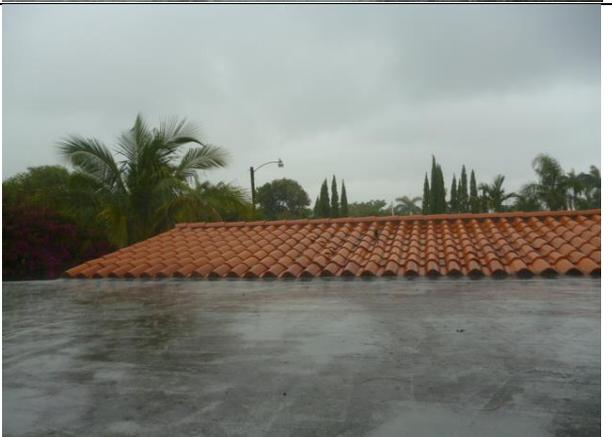
<p>(9)</p> <p><i>The subject property severely deteriorated flat roof surface cover is recommended to be replaced</i></p>
