HBCRA BID # FY 2015-2016-CRA003
 FDEM GRANT RESIDENTIAL WIND MITIGATION
 RETROFIT IMPROVEMENTS

RCMP PIS

7	HOMEOWNER NAME	Sealey, Brian J & Kathryn
8	PROPERTY ADDRESS	311 SW 10 Terrace
9	CITY AND ZIP	Hallandale Beach FL 33009
10	COUNTY	BROWARD
11	PROPERTY TAX ID NUMBER:	5142-28-29-0320

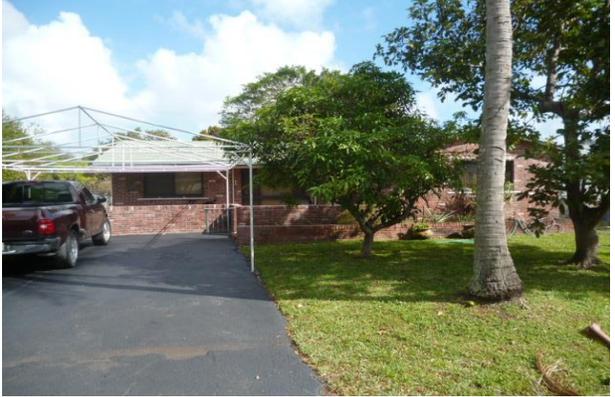
<p><i>As Photographed on</i></p> <p>Wednesday, February 03rd, 2016</p> <p>(1)</p> <p><i>The subject property building face West</i></p>

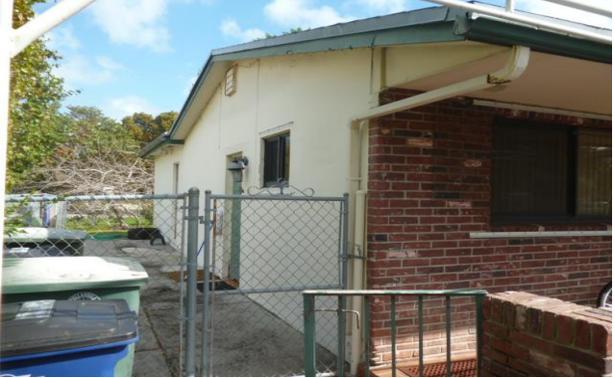
<p>(2)</p> <p><i>The subject property North elevation view</i></p>

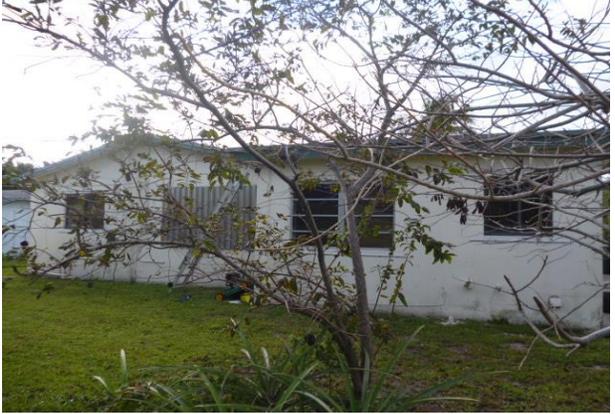
<p>(3)</p> <p><i>The subject property East elevation view</i></p>

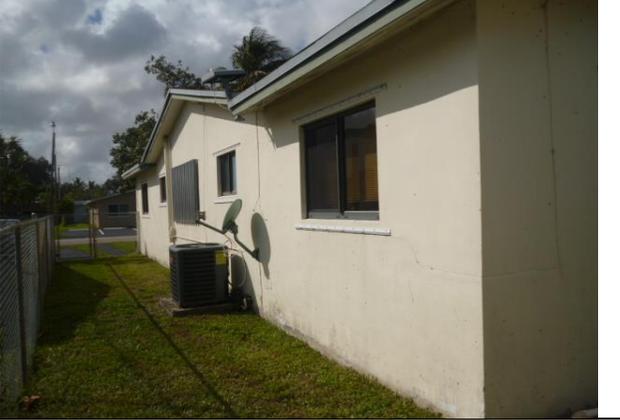
<p>(4)</p> <p><i>The subject property South elevation view</i></p>

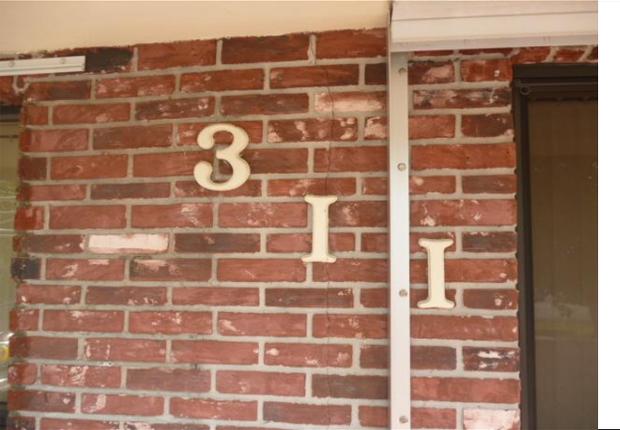
<p>(5)</p> <p><i>The subject property address signage 311</i></p>

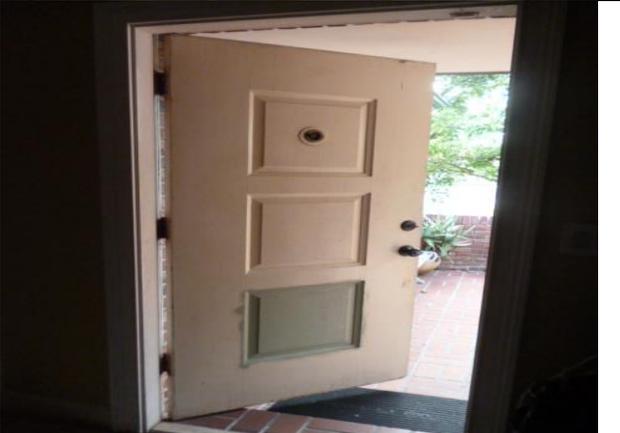
<p>(6)</p> <p><i>The subject property main entry door view</i></p>

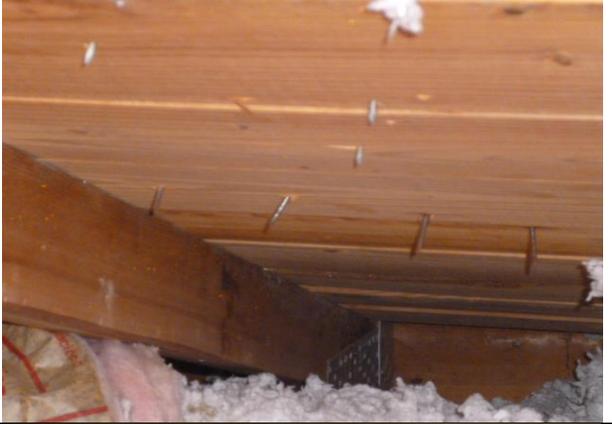
<p>(16)</p> <p><i>The subject property roof deck/structure attachments in the attic</i></p>

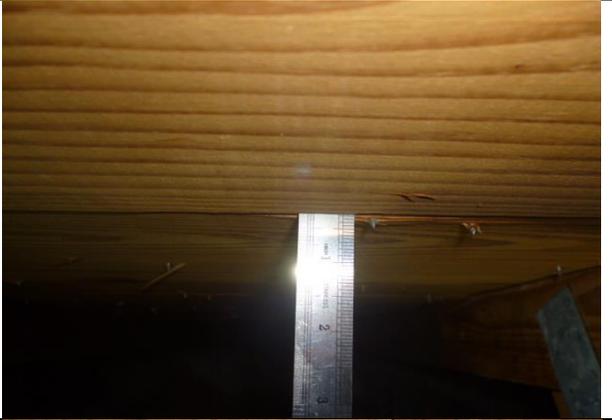
<p>(17)</p> <p><i>The subject property roof deck thickness view in the attic</i></p>

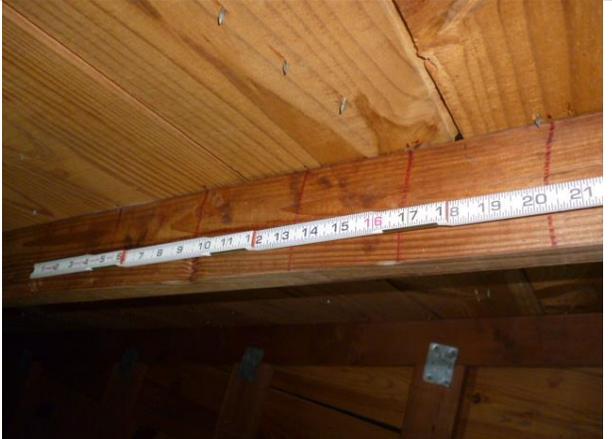
<p>(18)</p> <p><i>The subject property nail spacing view in the attic</i></p>

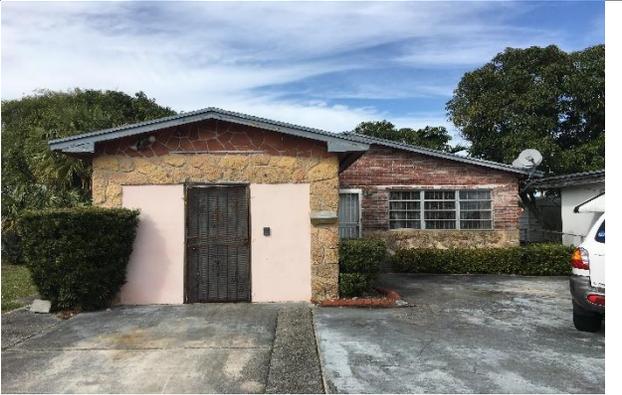
<p><i>As Photographed on</i></p> <p>Wednesday, February 10th, 2016</p> <p>(1)</p> <p><i>The subject property building face South</i></p>

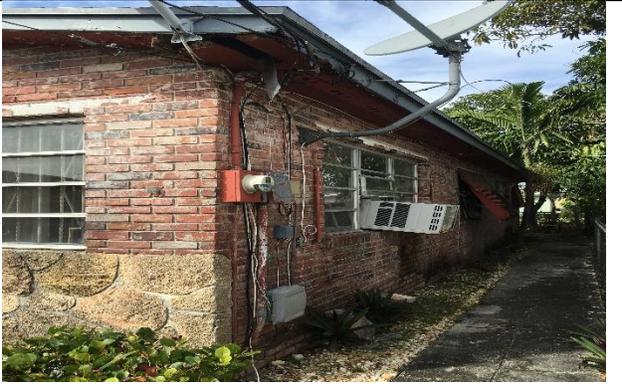
<p>(2)</p> <p><i>The subject property East elevation view</i></p>

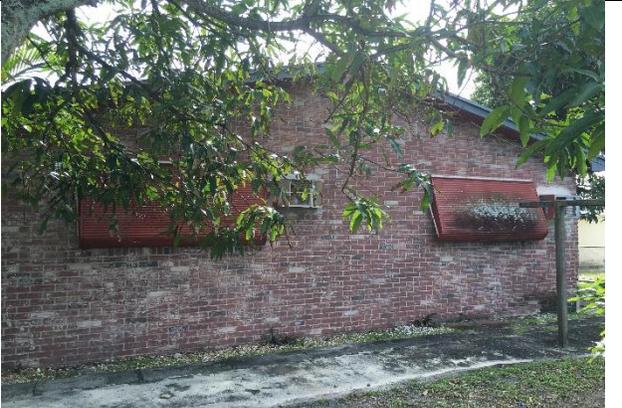
<p>(3)</p> <p><i>The subject property North elevation view</i></p>

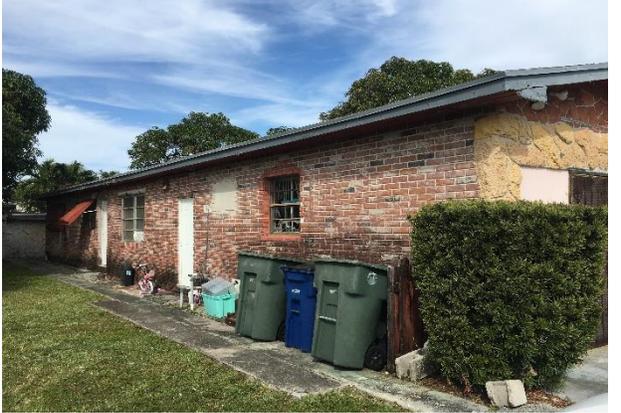
<p>(4)</p> <p><i>The subject property West elevation view</i></p>

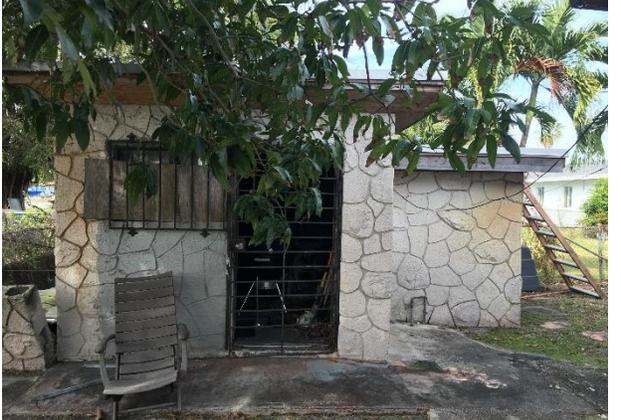
<p>(5)</p> <p><i>The subject property detached building view at NW corner of the property</i></p>

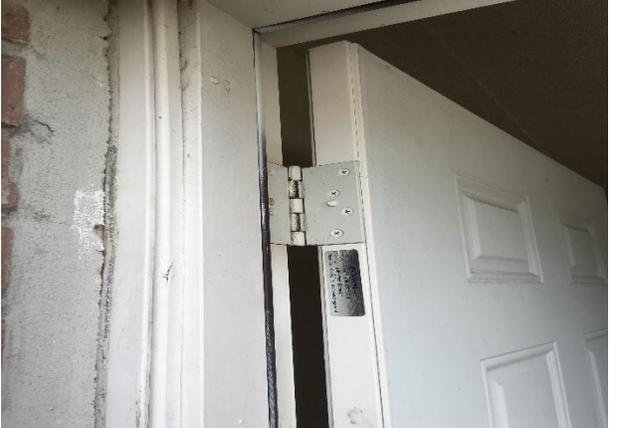
<p>(6)</p> <p><i>The subject property main entry door side view</i></p>

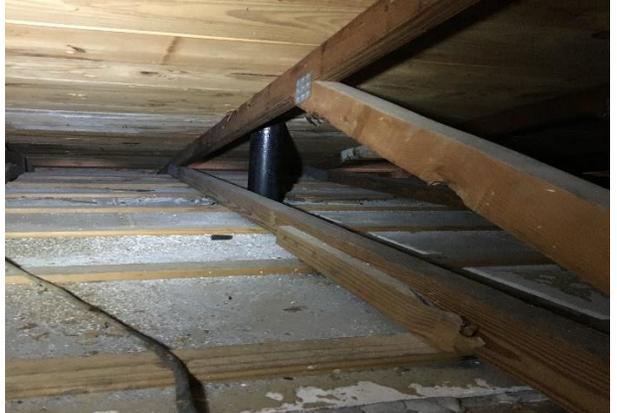
<p>(13)</p> <p><i>The subject property roof deck/structure attachments were blocked with personal objects in the attic</i></p>

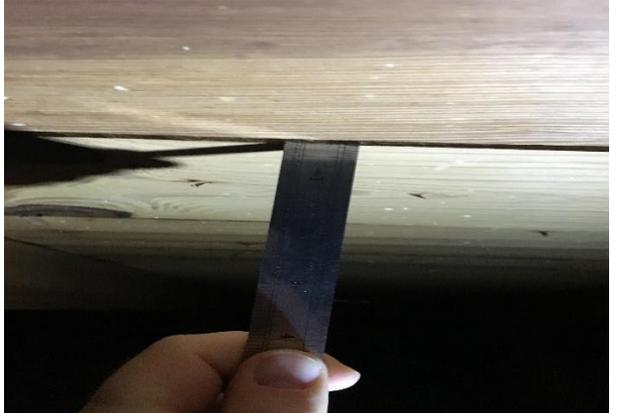
<p>(14)</p> <p><i>The subject property roof deck thickness view in the attic</i></p>

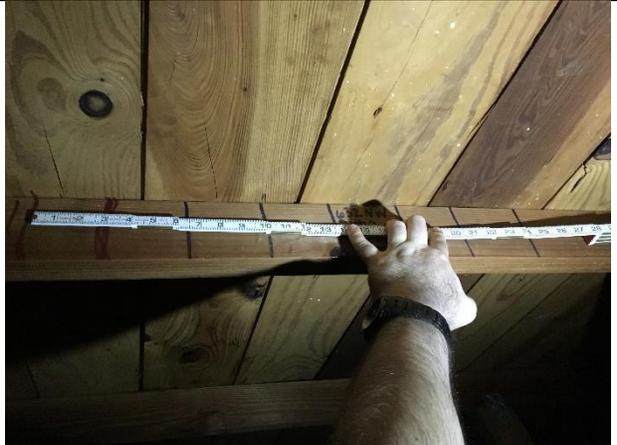
<p>(15)</p> <p><i>The subject property nail spacing view in the attic</i></p>

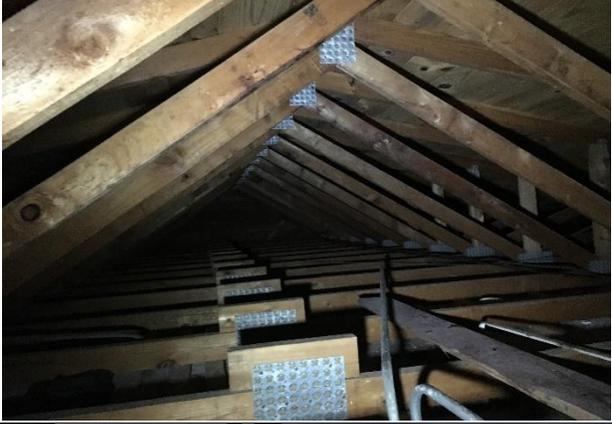
<p>(16)</p> <p><i>The subject property partial view of the attic</i></p>

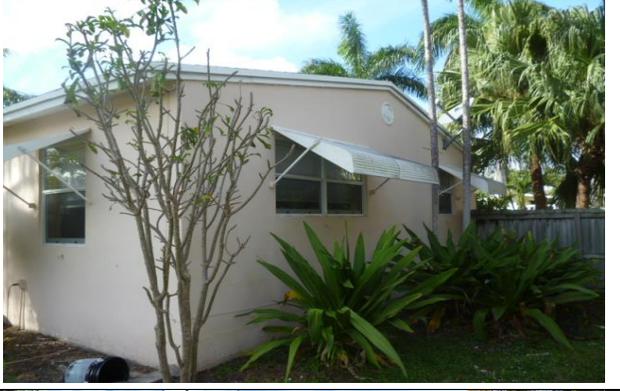
<p>(2)</p> <p><i>The subject property East elevation view</i></p>

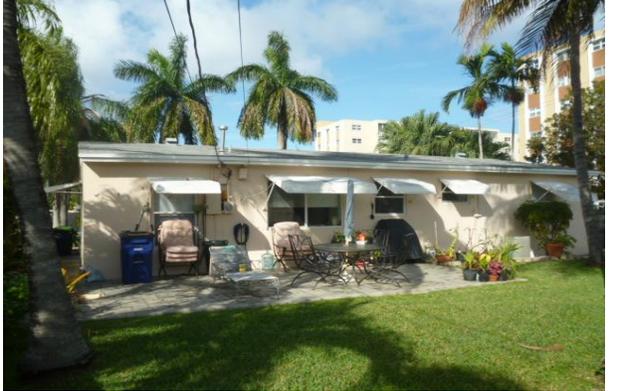
<p>(3)</p> <p><i>The subject property South elevation view</i></p>

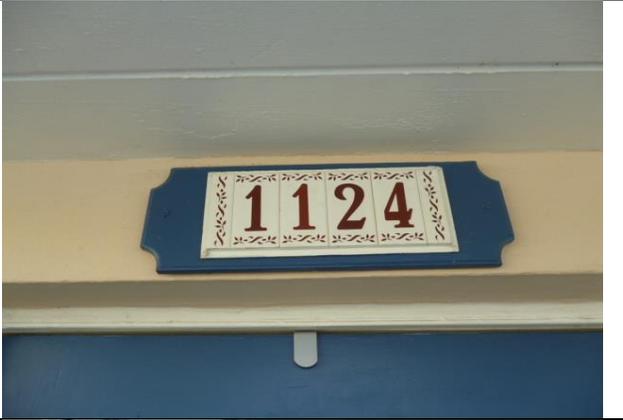
<p>(5)</p> <p><i>The subject property address signage 1124</i></p>

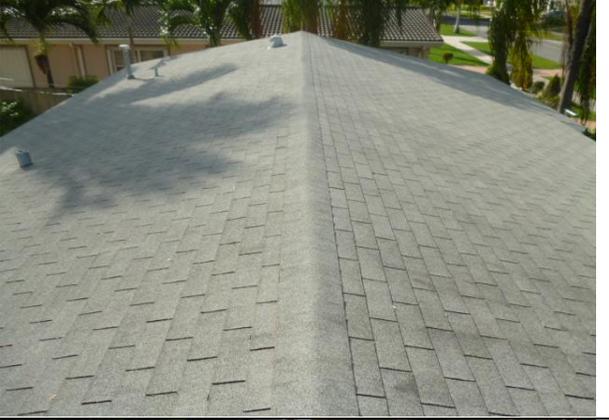
<p>(7)</p> <p><i>The subject property partial view of the main asphalt shingle roof</i></p>

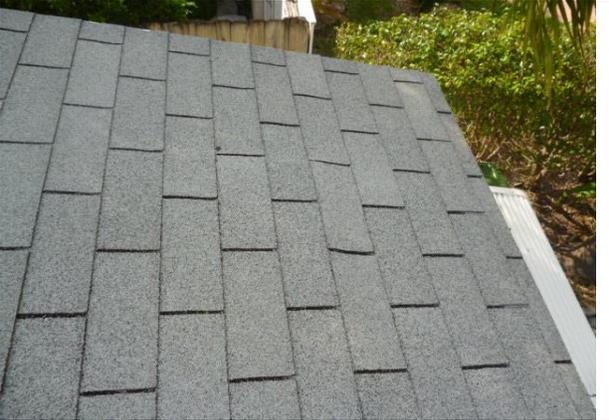
<p>(8)</p> <p><i>The subject property partial view of the main asphalt shingle roof</i></p>

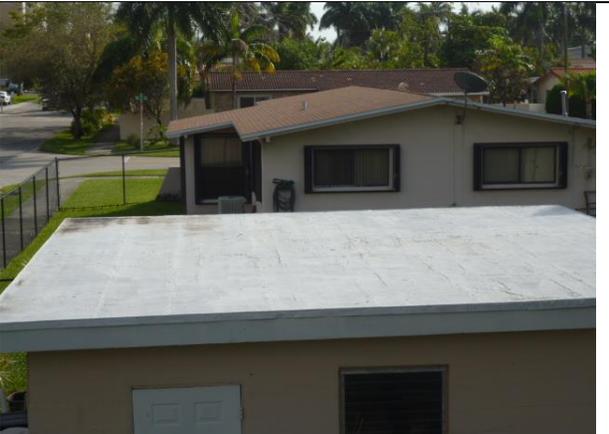
<p>(9)</p> <p><i>The subject property overall view of the detached garage building flat roof</i></p>

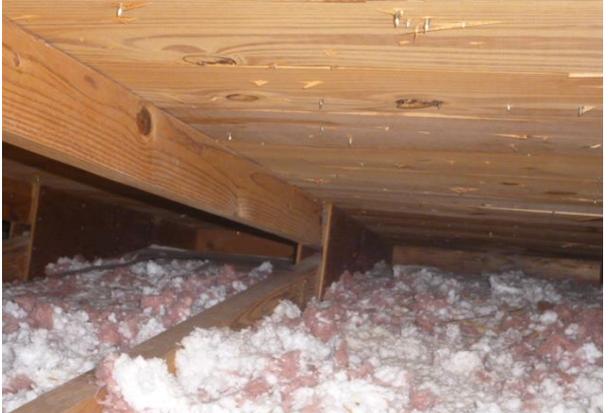
<p>(16)</p> <p><i>The subject property roof deck/structure attachments in the attic</i></p>

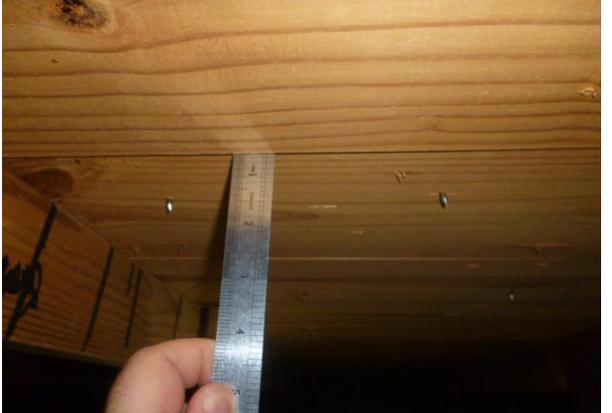
<p>(17)</p> <p><i>The subject property roof deck thickness view in the attic</i></p>

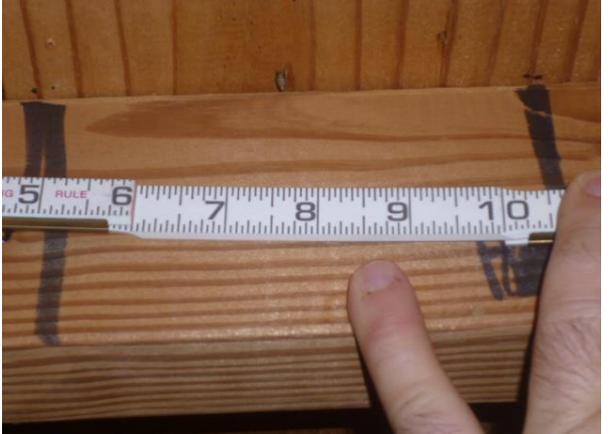
<p>(18)</p> <p><i>The subject property nail spacing view in the attic</i></p>

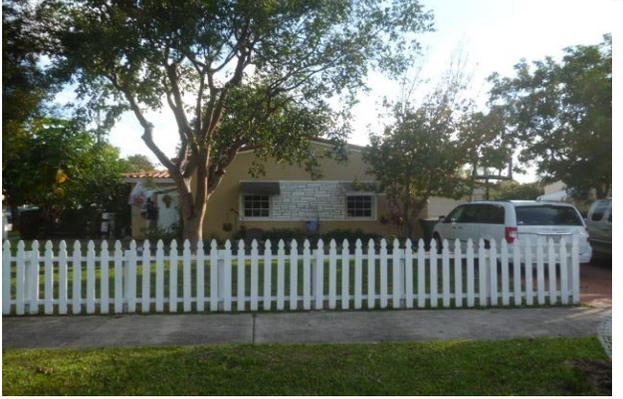
<p><i>As Photographed on</i></p> <p>Wednesday, February 03rd, 2016</p> <p>(1)</p> <p><i>The subject property building face North</i></p>

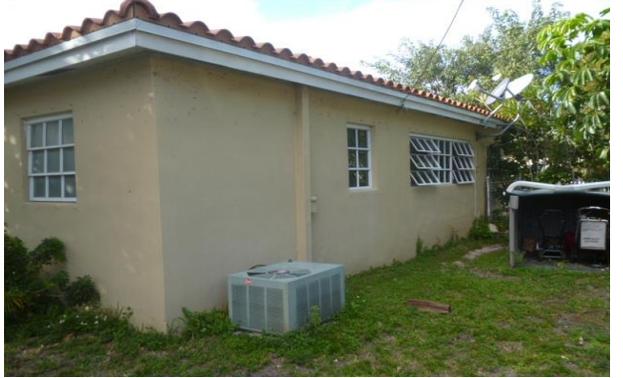
<p>(2)</p> <p><i>The subject property East elevation view</i></p>

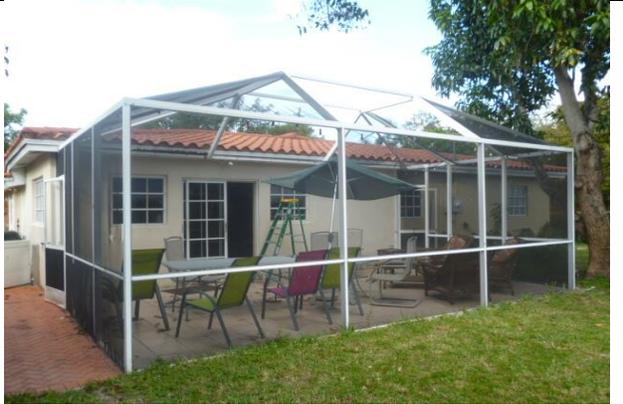
<p>(3)</p> <p><i>The subject property South elevation view</i></p>

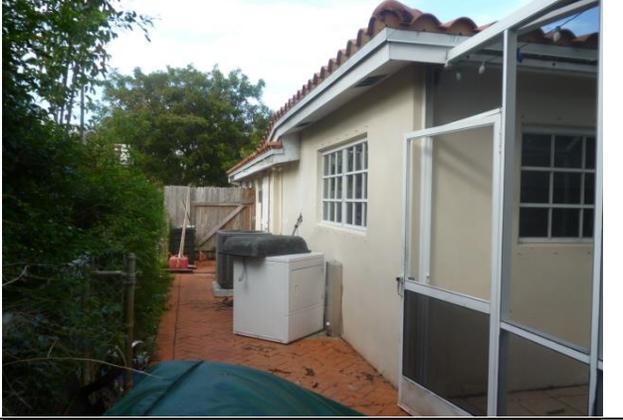
<p>(4)</p> <p><i>The subject property West elevation view</i></p>

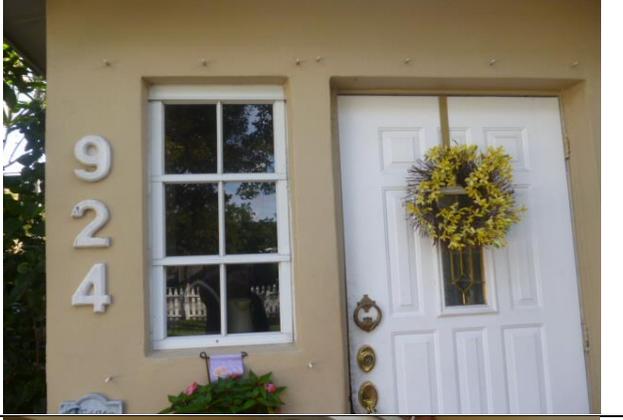
<p>(5)</p> <p><i>The subject property address signage 924</i></p>

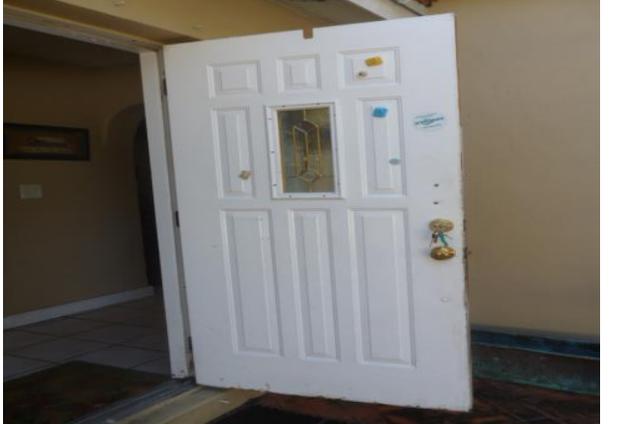
<p>(6)</p> <p><i>The subject property main entry door view</i></p>

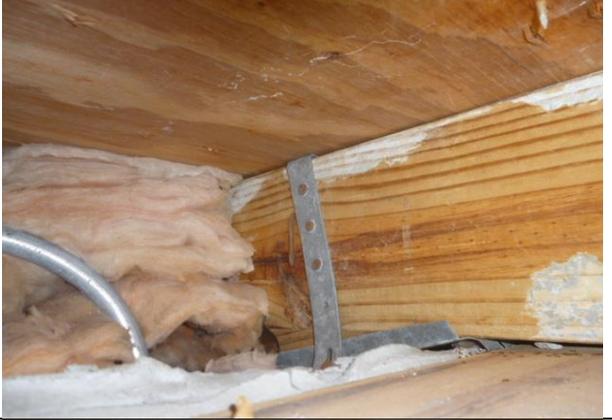
<p>(16)</p> <p><i>The subject property roof deck/structure attachments in the attic</i></p>

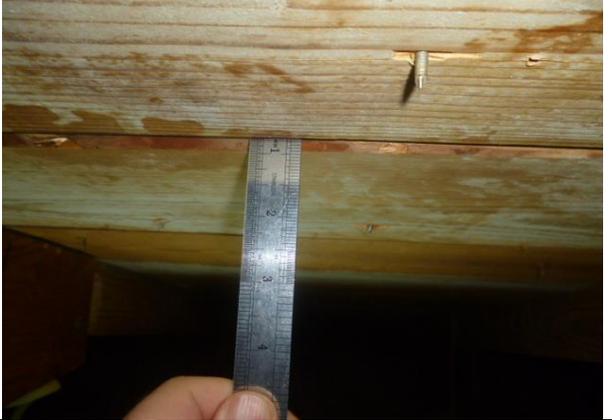
<p>(17)</p> <p><i>The subject property roof deck thickness view in the attic</i></p>

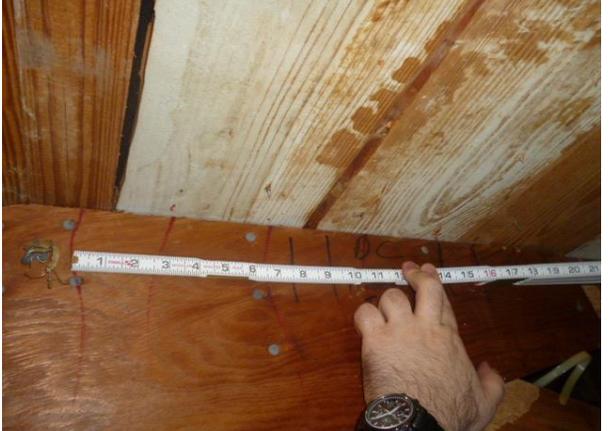
<p>(18)</p> <p><i>The subject property nail spacing view in the attic</i></p>

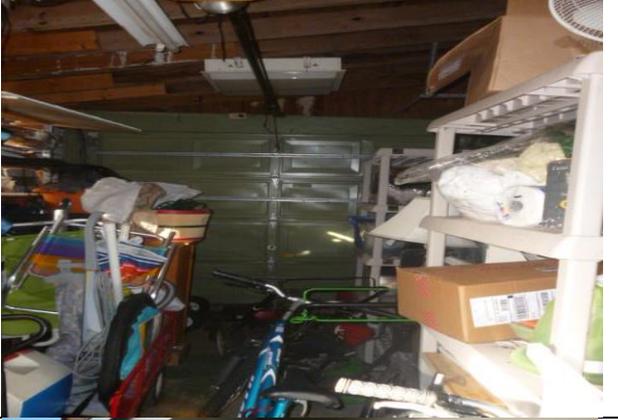
<p>(19)</p> <p><i>The subject property partial view of the garage</i></p>

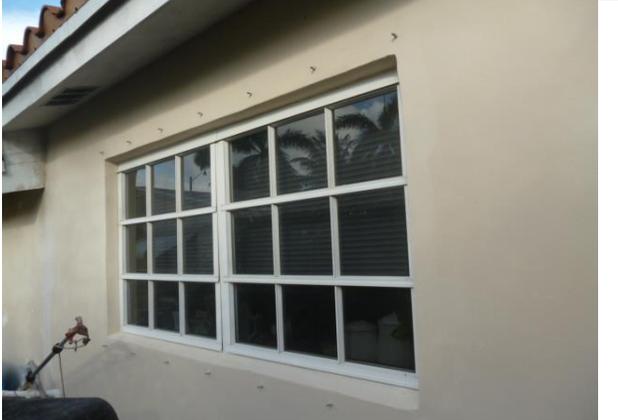
<p>(20)</p> <p><i>The subject property window glazed openings have no built-in storm protection</i></p>

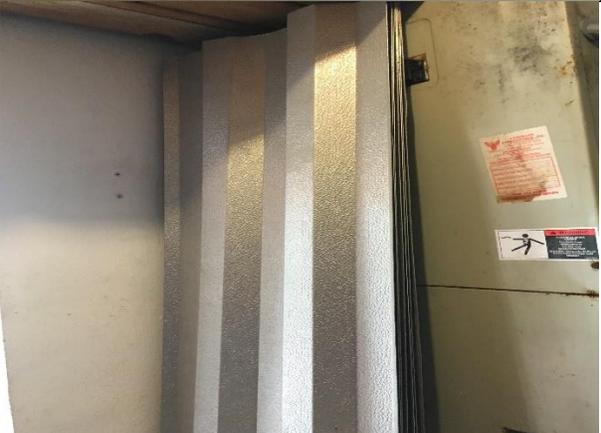
<p>(12)</p> <p><i>The aluminum shutters located in the property</i></p>

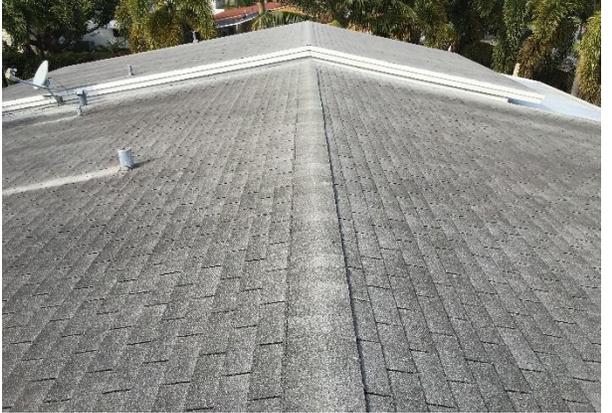
The main asphalt shingle roof system appears to be in poor condition along with excessive granular loss on the shingles. Damaged shingles and poor workmanship noted on the poorly repaired roof shingles. The protrusions need to be properly sealed around. The damaged main asphalt roof shingle roof needs immediate attention to be replaced.

<p>(7)</p> <p><i>The subject property partial view of the main asphalt shingle roof</i></p>

After viewing the structure inside and out, making various assessments and judgments, it is this inspector's opinion; the subject property building needs full replacement of the main asphalt shingle roof along with proper maintenance and servicing. The window glazed openings need built-in storm shutters to be fully protected, exterior door panels and frames also are in need of full replacement.

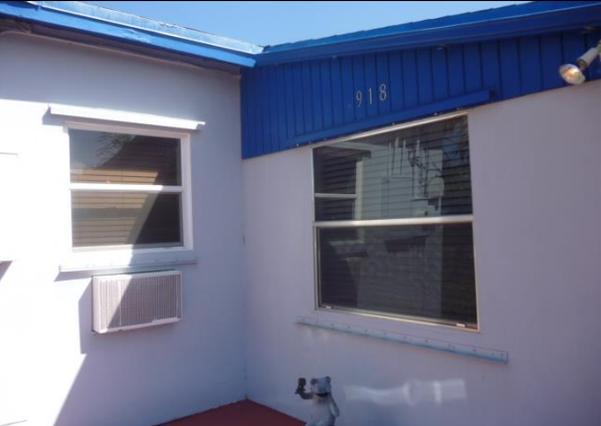
<p>(15)</p> <p><i>The subject property window glazed openings have no storm protection</i></p>

The window glazed openings have no storm protection. The window glazed openings and exterior doors/frames are recommended to be replaced with storm protected built-in storm shutters. The three exterior door panels, frames, and sashes are deteriorated along with seals are in poor condition and recommended to be replaced with proper exterior door panels as well.

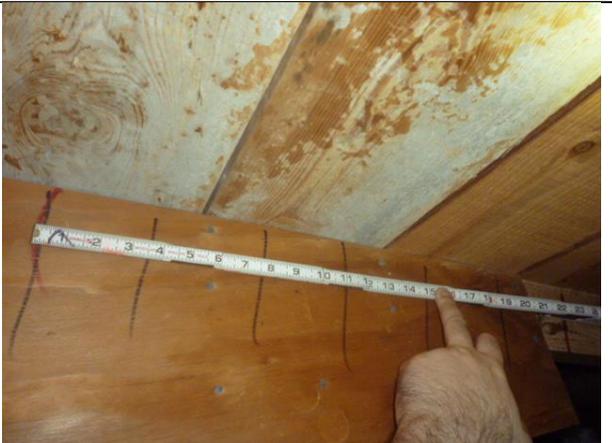
<p>(18)</p> <p><i>The subject property nail spacing view in the attic</i></p>

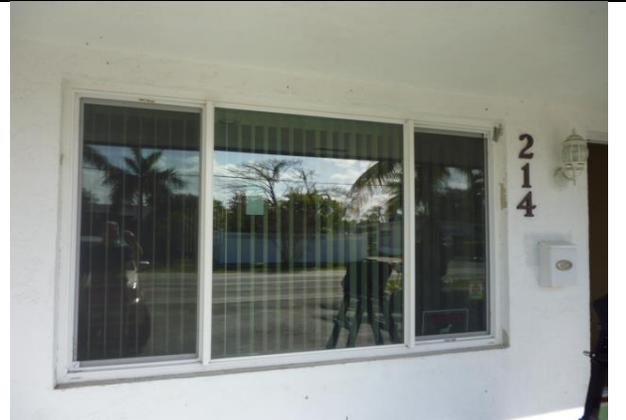
(7)

The subject property front (West) elevation window glazed /door openings have storm protection with impact glasses

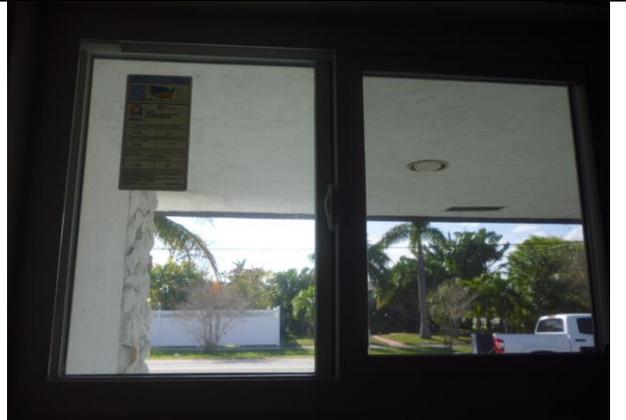
(8)

The subject property front (West) elevation window glazed /door openings have storm protection with impact glasses

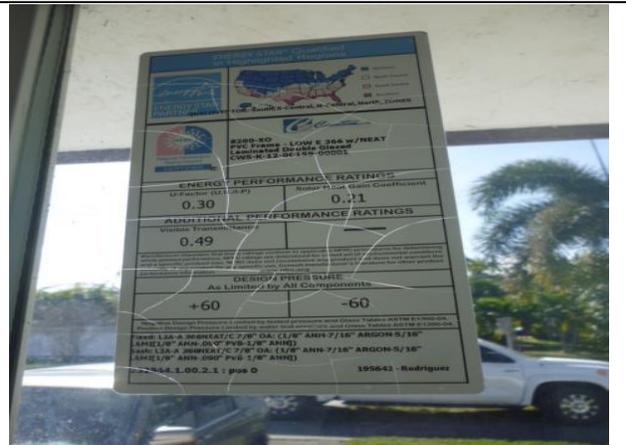
(9)

The subject property front (West) elevation window glazed /door openings impact glasses manufacturing labels

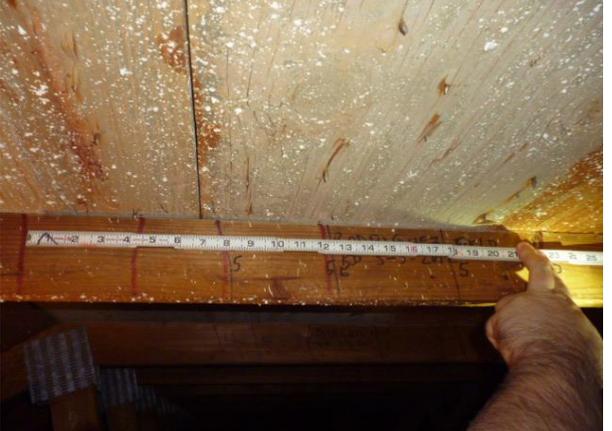
<p>(18)</p> <p><i>The subject property nail spacing view in the attic</i></p>

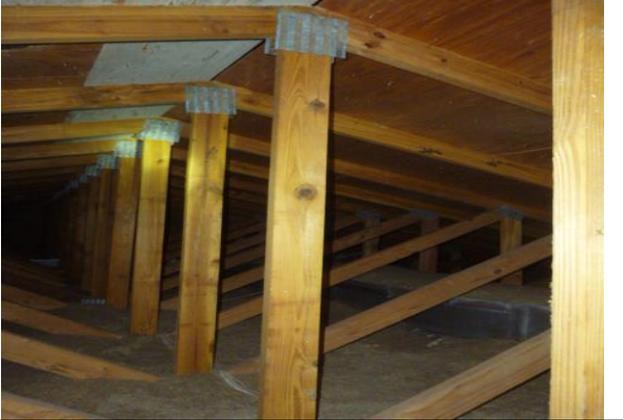
<p>(19)</p> <p><i>The subject property partial view of the attic</i></p>

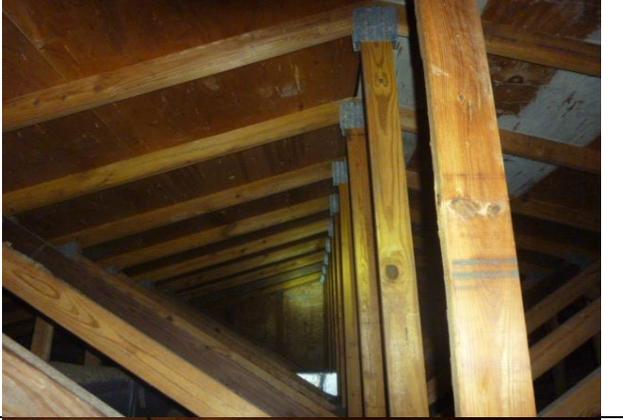
<p>(20)</p> <p><i>The subject property partial view of the attic</i></p>

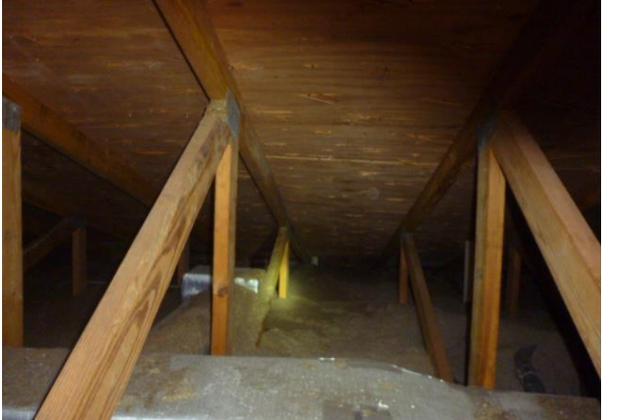
<p>(21)</p> <p><i>The subject property partial view of the attic</i></p>

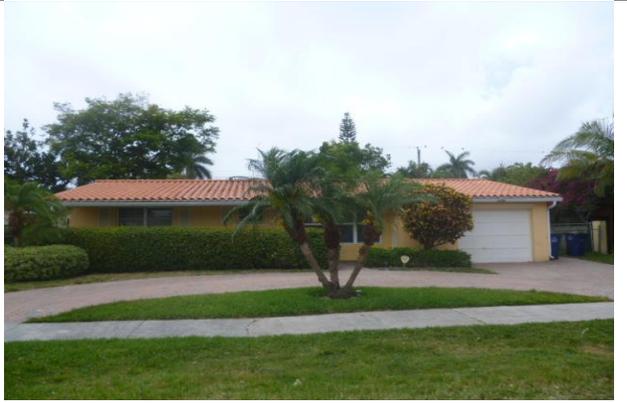
<p><i>As Photographed on</i></p> <p>Tuesday, May 17th, 2016</p> <p>(1)</p> <p><i>The subject property building face North</i></p>

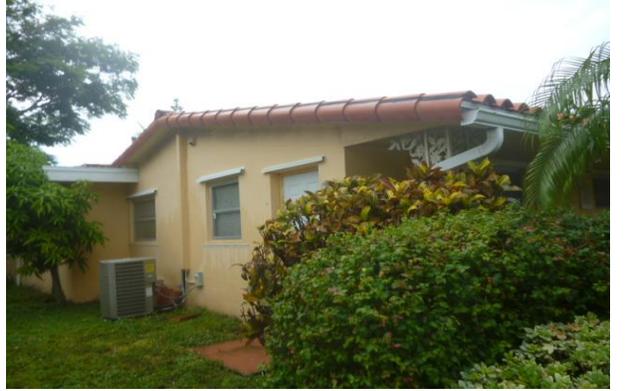
<p>(2)</p> <p><i>The subject property East elevation view</i></p>

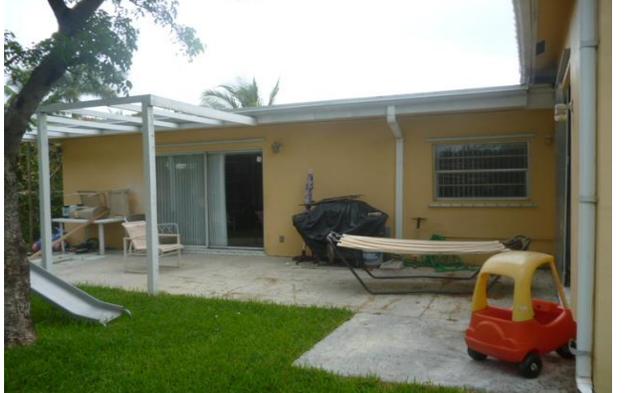
<p>(3)</p> <p><i>The subject property South elevation view</i></p>

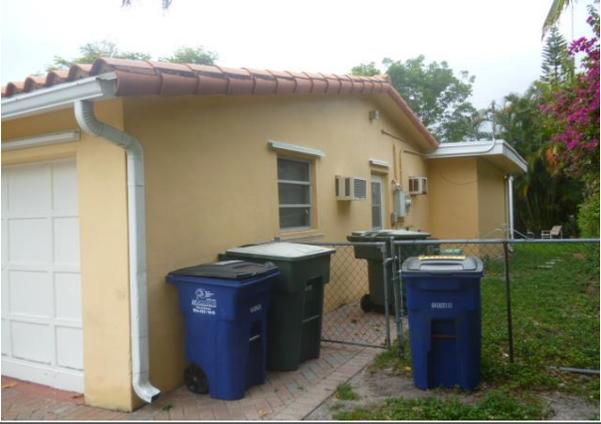
<p>(4)</p> <p><i>The subject property West elevation view</i></p>

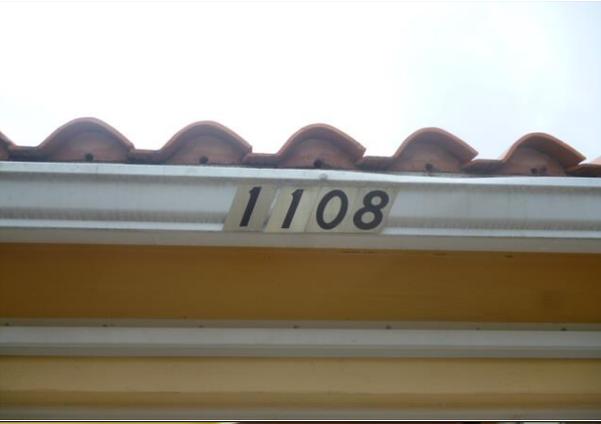
<p>(5)</p> <p><i>The subject property address signage 1108</i></p>

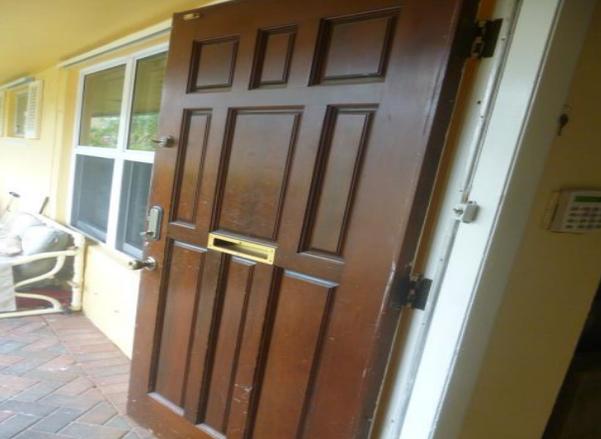
<p>(6)</p> <p><i>The subject property main entry door view</i></p>

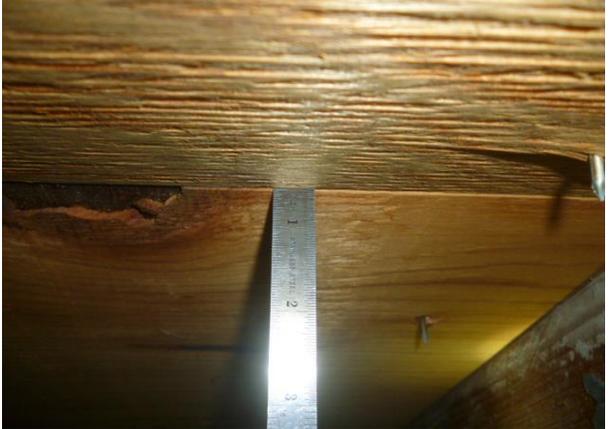
<p>(14)</p> <p><i>The subject property roof deck thickness view in the attic</i></p>

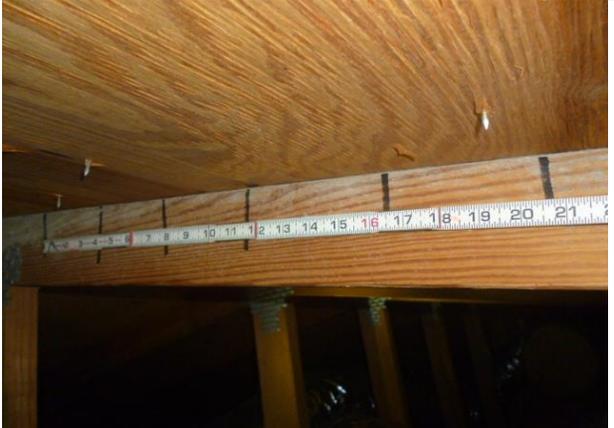
<p>(15)</p> <p><i>The subject property nail spacing view in the attic</i></p>

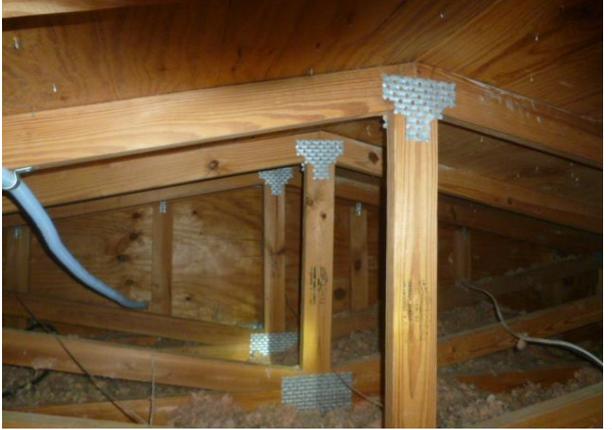
<p>(16)</p> <p><i>The subject property roof truss system gable ends need to be reinforced</i></p>

The main clay tile roof system appears to be in fair condition with some exception of broken/cracked tiles that need to be replaced soon. The flat roof surface has been significantly deteriorated and it is highly recommended to be replaced soon. The protrusions on the roof surface need to be always properly sealed and maintained. The roof wooden deck panels, fascia boards, and soffit/eaves have some deterioration. Those fascia boards and soffit need to be partially repaired and maintained along with proper vent screens and they all should be maintained as needed in the future. Double gable end bracing reinforcement is highly recommended for the subject property.

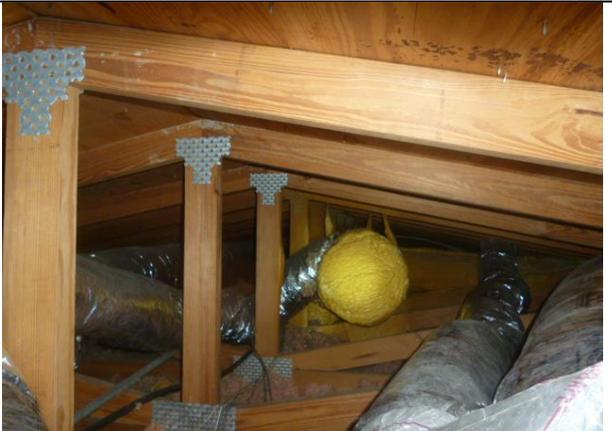
<p>(17)</p> <p><i>The subject property partial view in the attic</i></p>

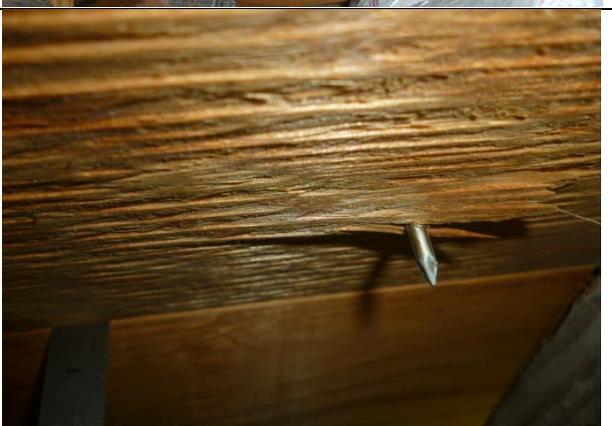
<p>(18)</p> <p><i>The subject property nail sizes view in the attic</i></p>
